TACOMA WATER DIVISION

Report Date: October 16, 2013

DOH System ID	86800 N	Survey Dates	8/9/13 – 8/12/13
System Type	Group A Community	Operating Permit	Green
Surveyor	John Ryding

Tacoma Water's Fletcher Heights Reservoir

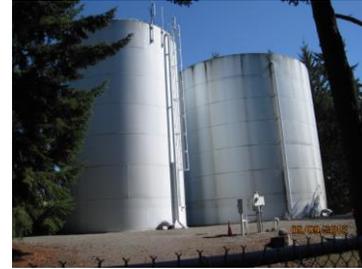
The UP tanks consist of two steel standpipe type storage tanks that appear to operate in parallel. They appeared to be in good condition. They have physically separated inlets and outlets. The tanks are fed by the 531 pressure zone through an altitude valve and they feed the 478 zone. With separate inlets and outlets it was reported that stagnation problems have not been experienced by the tanks. *The overflow outlet for the two tanks is located*

in a manhole at the end of a downward facing elbow. The actual outlet opening could not be observed but it was reported that the outlet was screened. This must be verified because if it is not it would be a Significant Deficiency. The tanks were originally outfitted with float gauges that are still operational but are not used. *The conduit piping for the gauge wires faces downward but is unscreened. This is an unnecessary unprotected opening and should be capped or removed as soon as possible.*

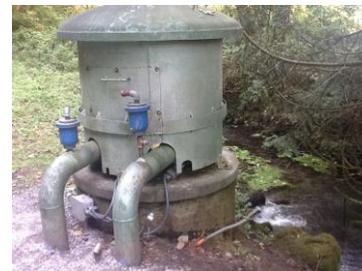
- There were unprotected openings into the pump wetwell between the cistern lid and the cistern itself (pictured at left). These openings have since been eliminated by the time of the report.

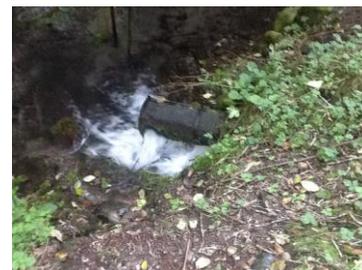
- *There was an apparent cross connection between the spring collection manhole "blowoff" and the creek. The blowoff discharge was submerged and was isolated from the spring collection manhole by a single gate valve.*

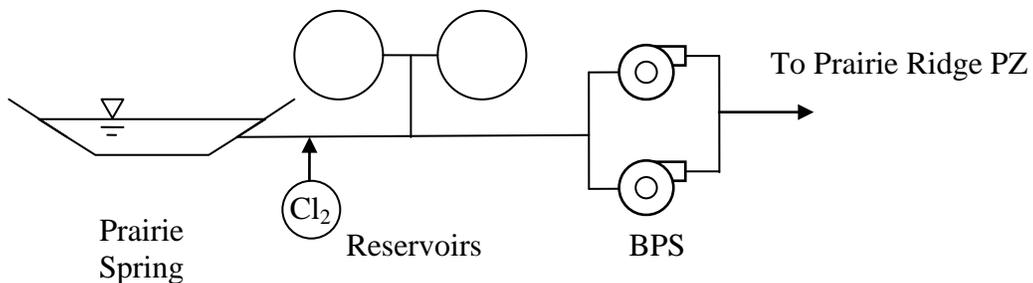
The reservoirs appeared to be in fair condition. *The vent screens were loose and need to be tightened.* Based on the schematic shown above it appears the reservoirs cannot be used for contact time in providing a CT of 6 to the spring.

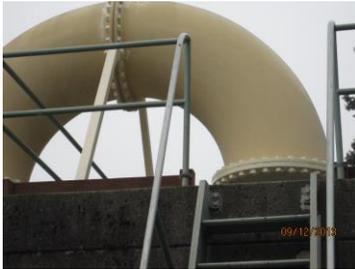
There is an emergency blow off at the north end of the reservoir site that allows direct access to PL1 (pictured at left). **The blowoff is covered by a wide mesh grate which must be protected by a finer mesh screen.** The hatch drains were in good condition and have proper drainage. **The hatch drain discharges should be covered with a fine mesh screen. This is true of all of the at grade reservoirs.**

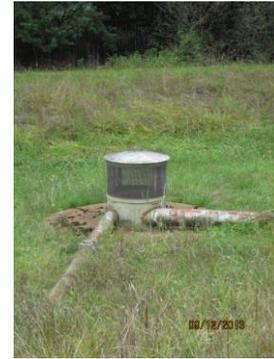
The globe valve on the pump waste blow off line was found to be in the open position while the well pumps were out of service. This is different from the wells of the South Tacoma Wellfield whose globe valves are closed when the wells are off-line. ***The blow-off discharge is located in a grassy basin (pictured). This is a potential cross connection with the wells and it needs to be reconstructed to provide an adequate air gap.***

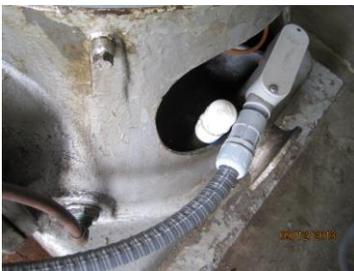
Wells SE#2 and SE#6 are treated for corrosion control using NaOH injection. In the facility, injection pumps have anti-siphon valves and the post-injection pH analyzer is located in the wellhouse for SE#2. The facility was last used in August 2012. There is also a chlorine monitor located at the site. Both wells have raw water sample taps and neither have vents. At the time of the survey the free chlorine residual in the distribution system was 0.70 mg/L with a pH of 7.75. ***It appears a vent could be easily added to a pipe stub coming from the pedestal of Well SE#2 (pictured).***

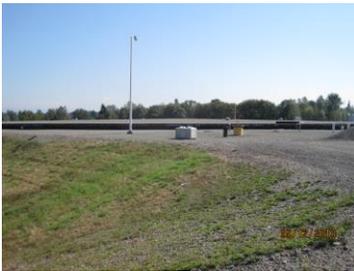
The overflow outlet for the reservoir was located in a vault below the reservoir. The outlet could not be seen in the vault. It is not clear whether there is an adequate air gap into the vault. The outlet may be less than 32 feet in elevation below the reservoir overflow. **The overflow outlet must be verified to be more than 32 feet below the reservoir overflow elevation. If it is not, this is a Significant Deficiency and an adequate air gap must be installed between the outlet and the vault. Also, the presence of a screen on the outlet must be verified.**

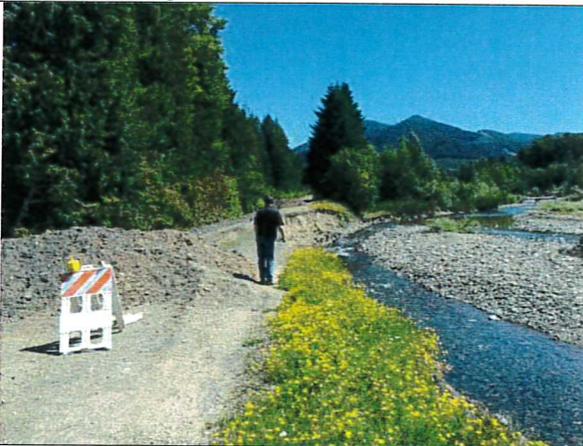
Washout on Road to Lester
