Cowlitz River Project Fish Passage: Current Trends 2018 - 2023

Cowlitz Annual Project Review and Science Conference

September 4th, 2024

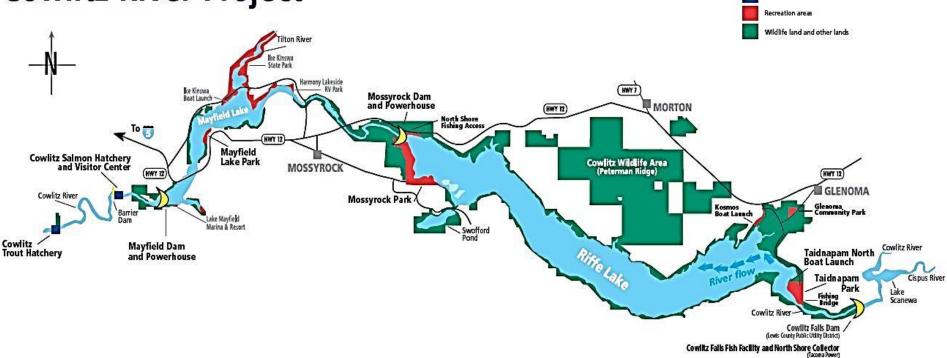
Dams and powerhouses Hatcheries

Cowlitz River Project Dams and powerhouses Hatcheries Recreation areas Wildlife land and other lands Ike Kinswa State Park ke Kinswa Boat Launch Mossyrock Dam and Powerhouse MORTON (HWY 12) To 📆 Mayfield Lake Park Cowlitz Salmon Hatchery and Visitor Center Cowlitz Wildlife Area (Peterman Ridge) MOSSYROCK GLENOMA Cowlitz River Mossyrock Park Glenoma Community Park Lake Mayfield Marina & Resort Cowlitz **Mayfield Dam** Cowlitz River **Trout Hatchery** Taidnapam North Boat Launch and Powerhouse Taidnapam Cispu: liver Park Lake Scanewa Cowlitz Falls Dam (Lewis County Public Utility District) Cowiltz Falls Fish Facility and North Shore Collector

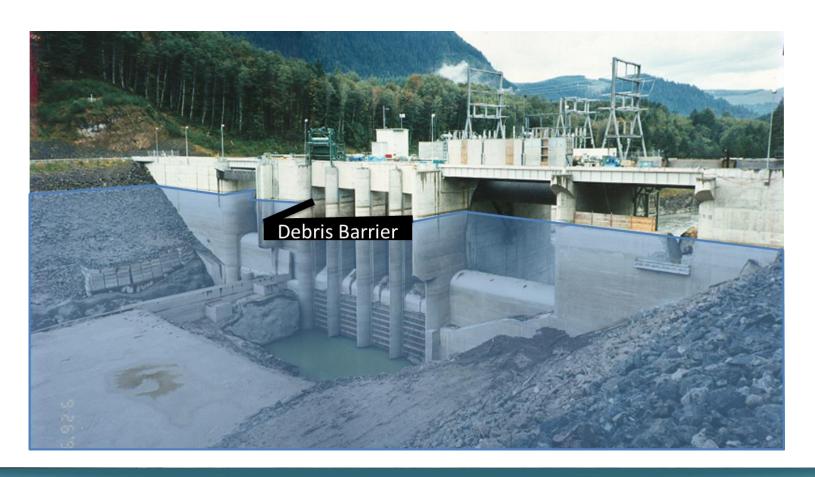
Low Entrance Efficiency

Behavior near debris barrier

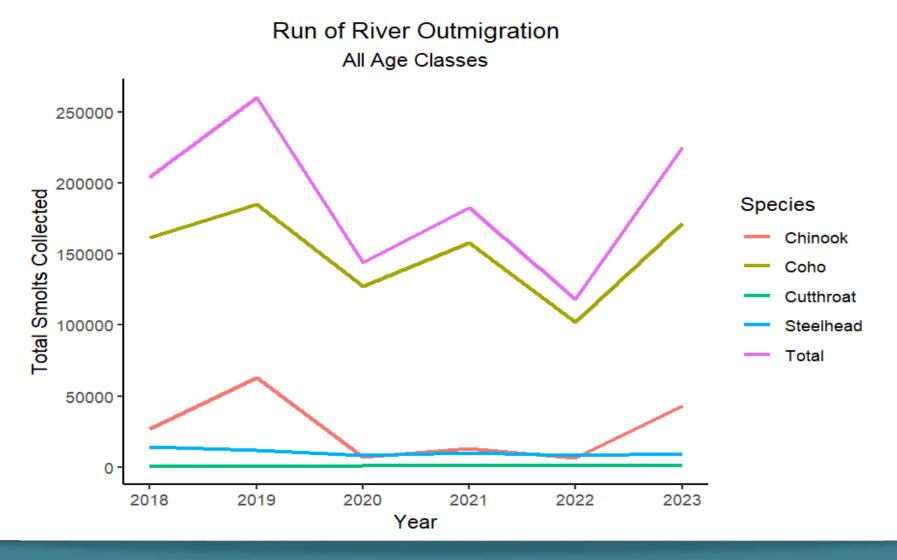
Run of River Outmigration

Begin Date	End Date
2018	March 1	Aug. 31
2019	March 1	Sept. 13
2020	Feb. 3	Sept. 30
2021	March 15	Sept. 30
2022	March 15	Sept. 30
2023	March 15	Sept. 30

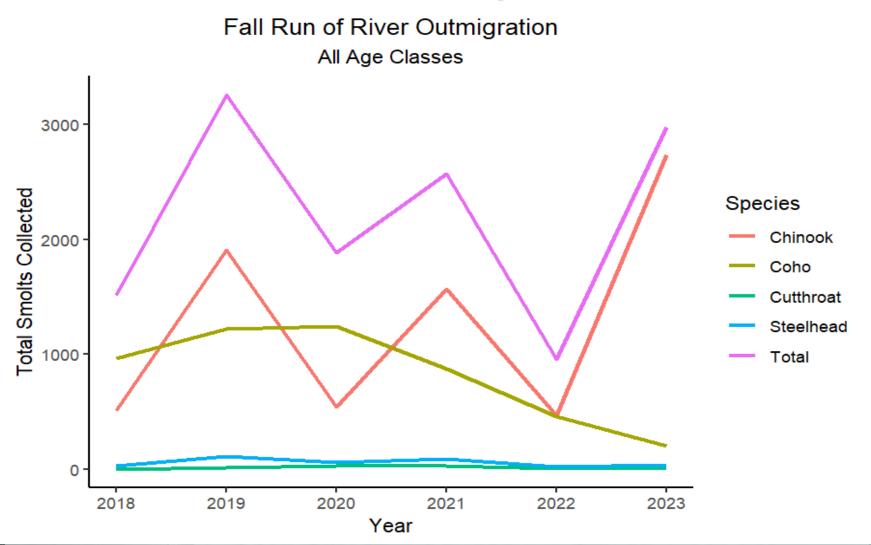
Run of River Fall Migration

Generally operate for four consecutive weeks of three-day, 72-hour blocks.

Begin Date	End Date	Hours (days)
2018	Nov. 8	Dec. 21	203 (8.5)
2019	Oct. 22	Nov. 15	288 (12.0)
2020	Oct. 6	Oct. 30	294 (12.3)
2021	Oct. 5	Oct. 29	279 (11.6)
2022	Oct. 4	Oct. 28	288 (12.0)
2023	Oct. 3	Oct. 27	288 (12.0)

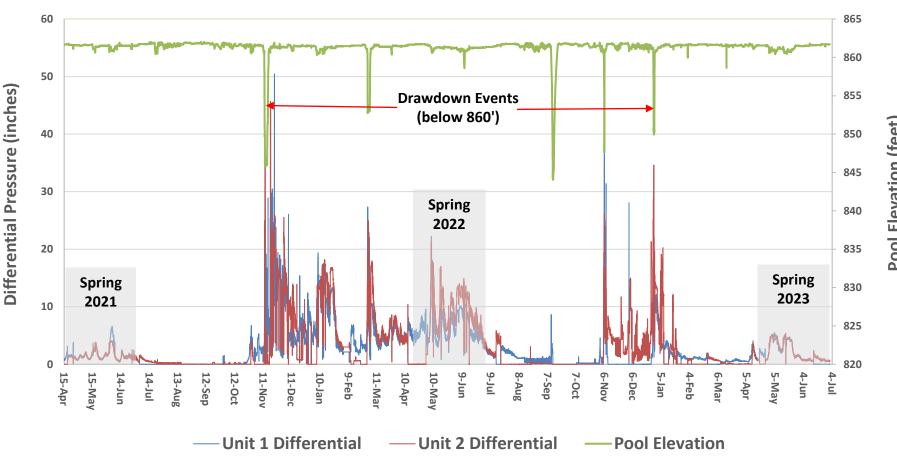
Trash Rack Occlusion

Pool Elevation (feet)

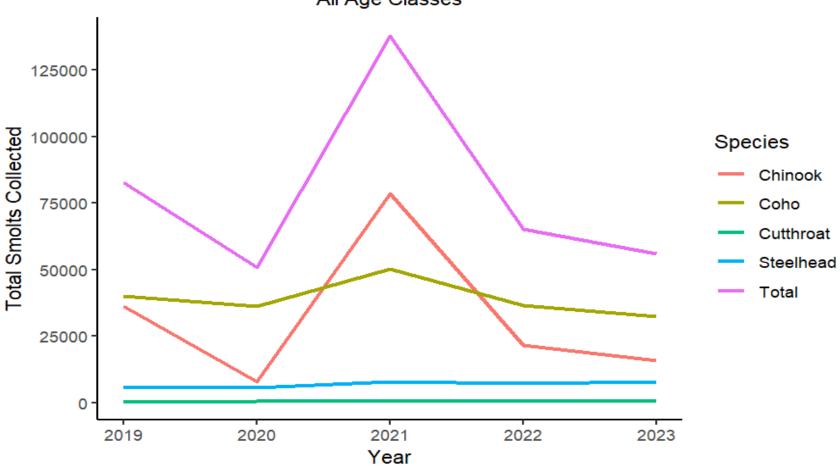
5-year Run of River Outmigration

Mayfield Run of River Outmigration
All Age Classes
