Cowlitz Falls North Shore Collector Fish Collection 2017 - 2022

Gabe McGuire Cowlitz Falls Fish Facility Manager

Cowlitz Annual Project Review and Science Conference

August 22, 2023

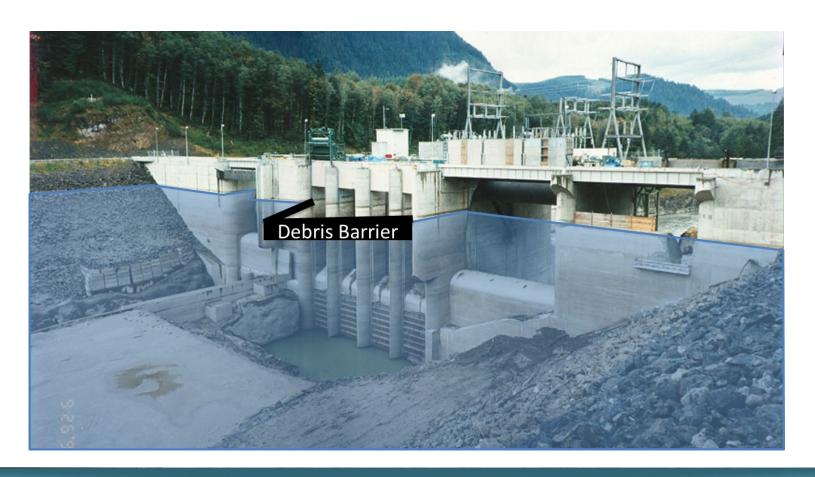
Low Entrance Efficiency

Behavior near debris barrier

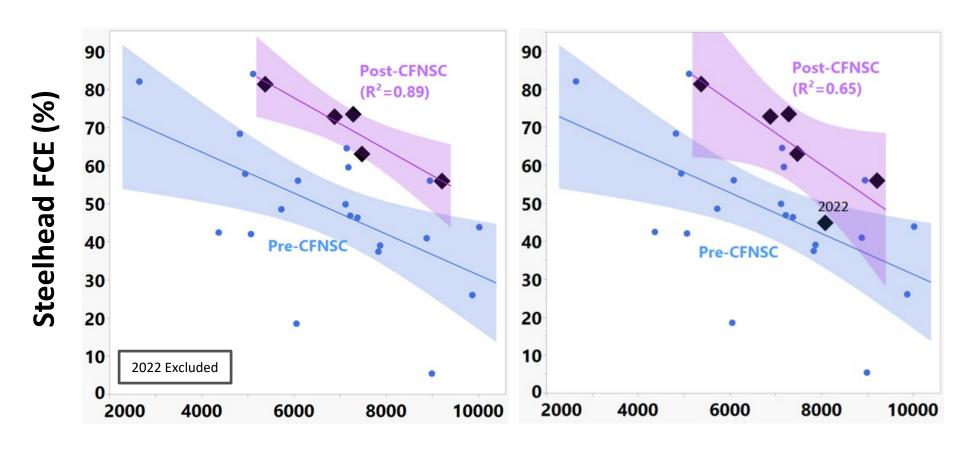
Water Year Comparison - Steelhead

Mean Discharge (April 15 – June 30)

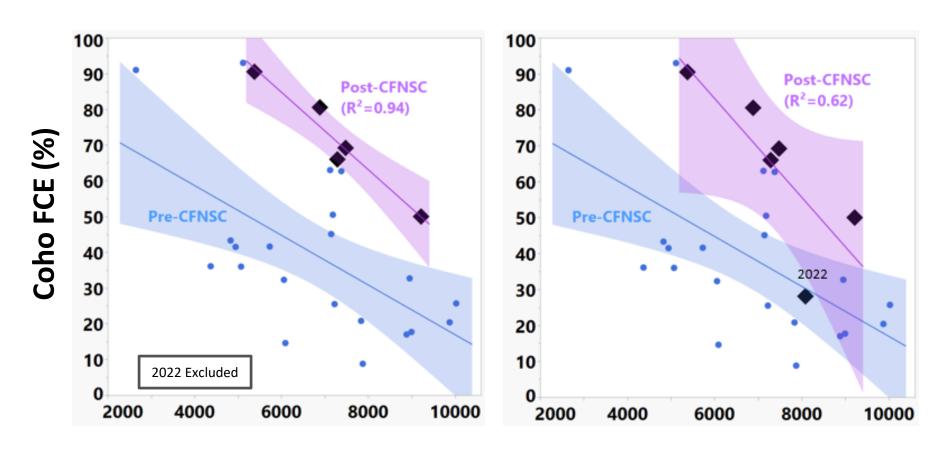
Water Year Comparison - Coho

Mean Discharge (April 15 – June 30)

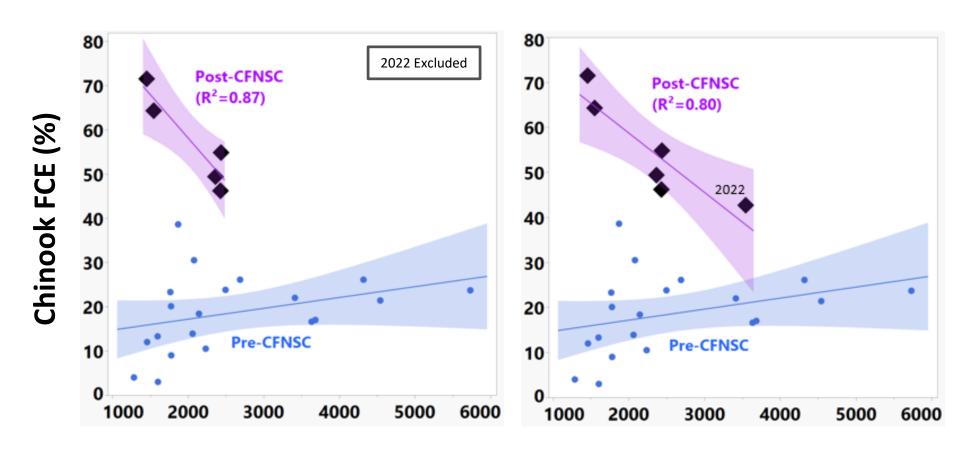
Water Year Comparison - Chinook

Mean Discharge (July 1 – August 31)
