Figure 1
Winter Average High Flow Depth
Cowlitz River Restoration

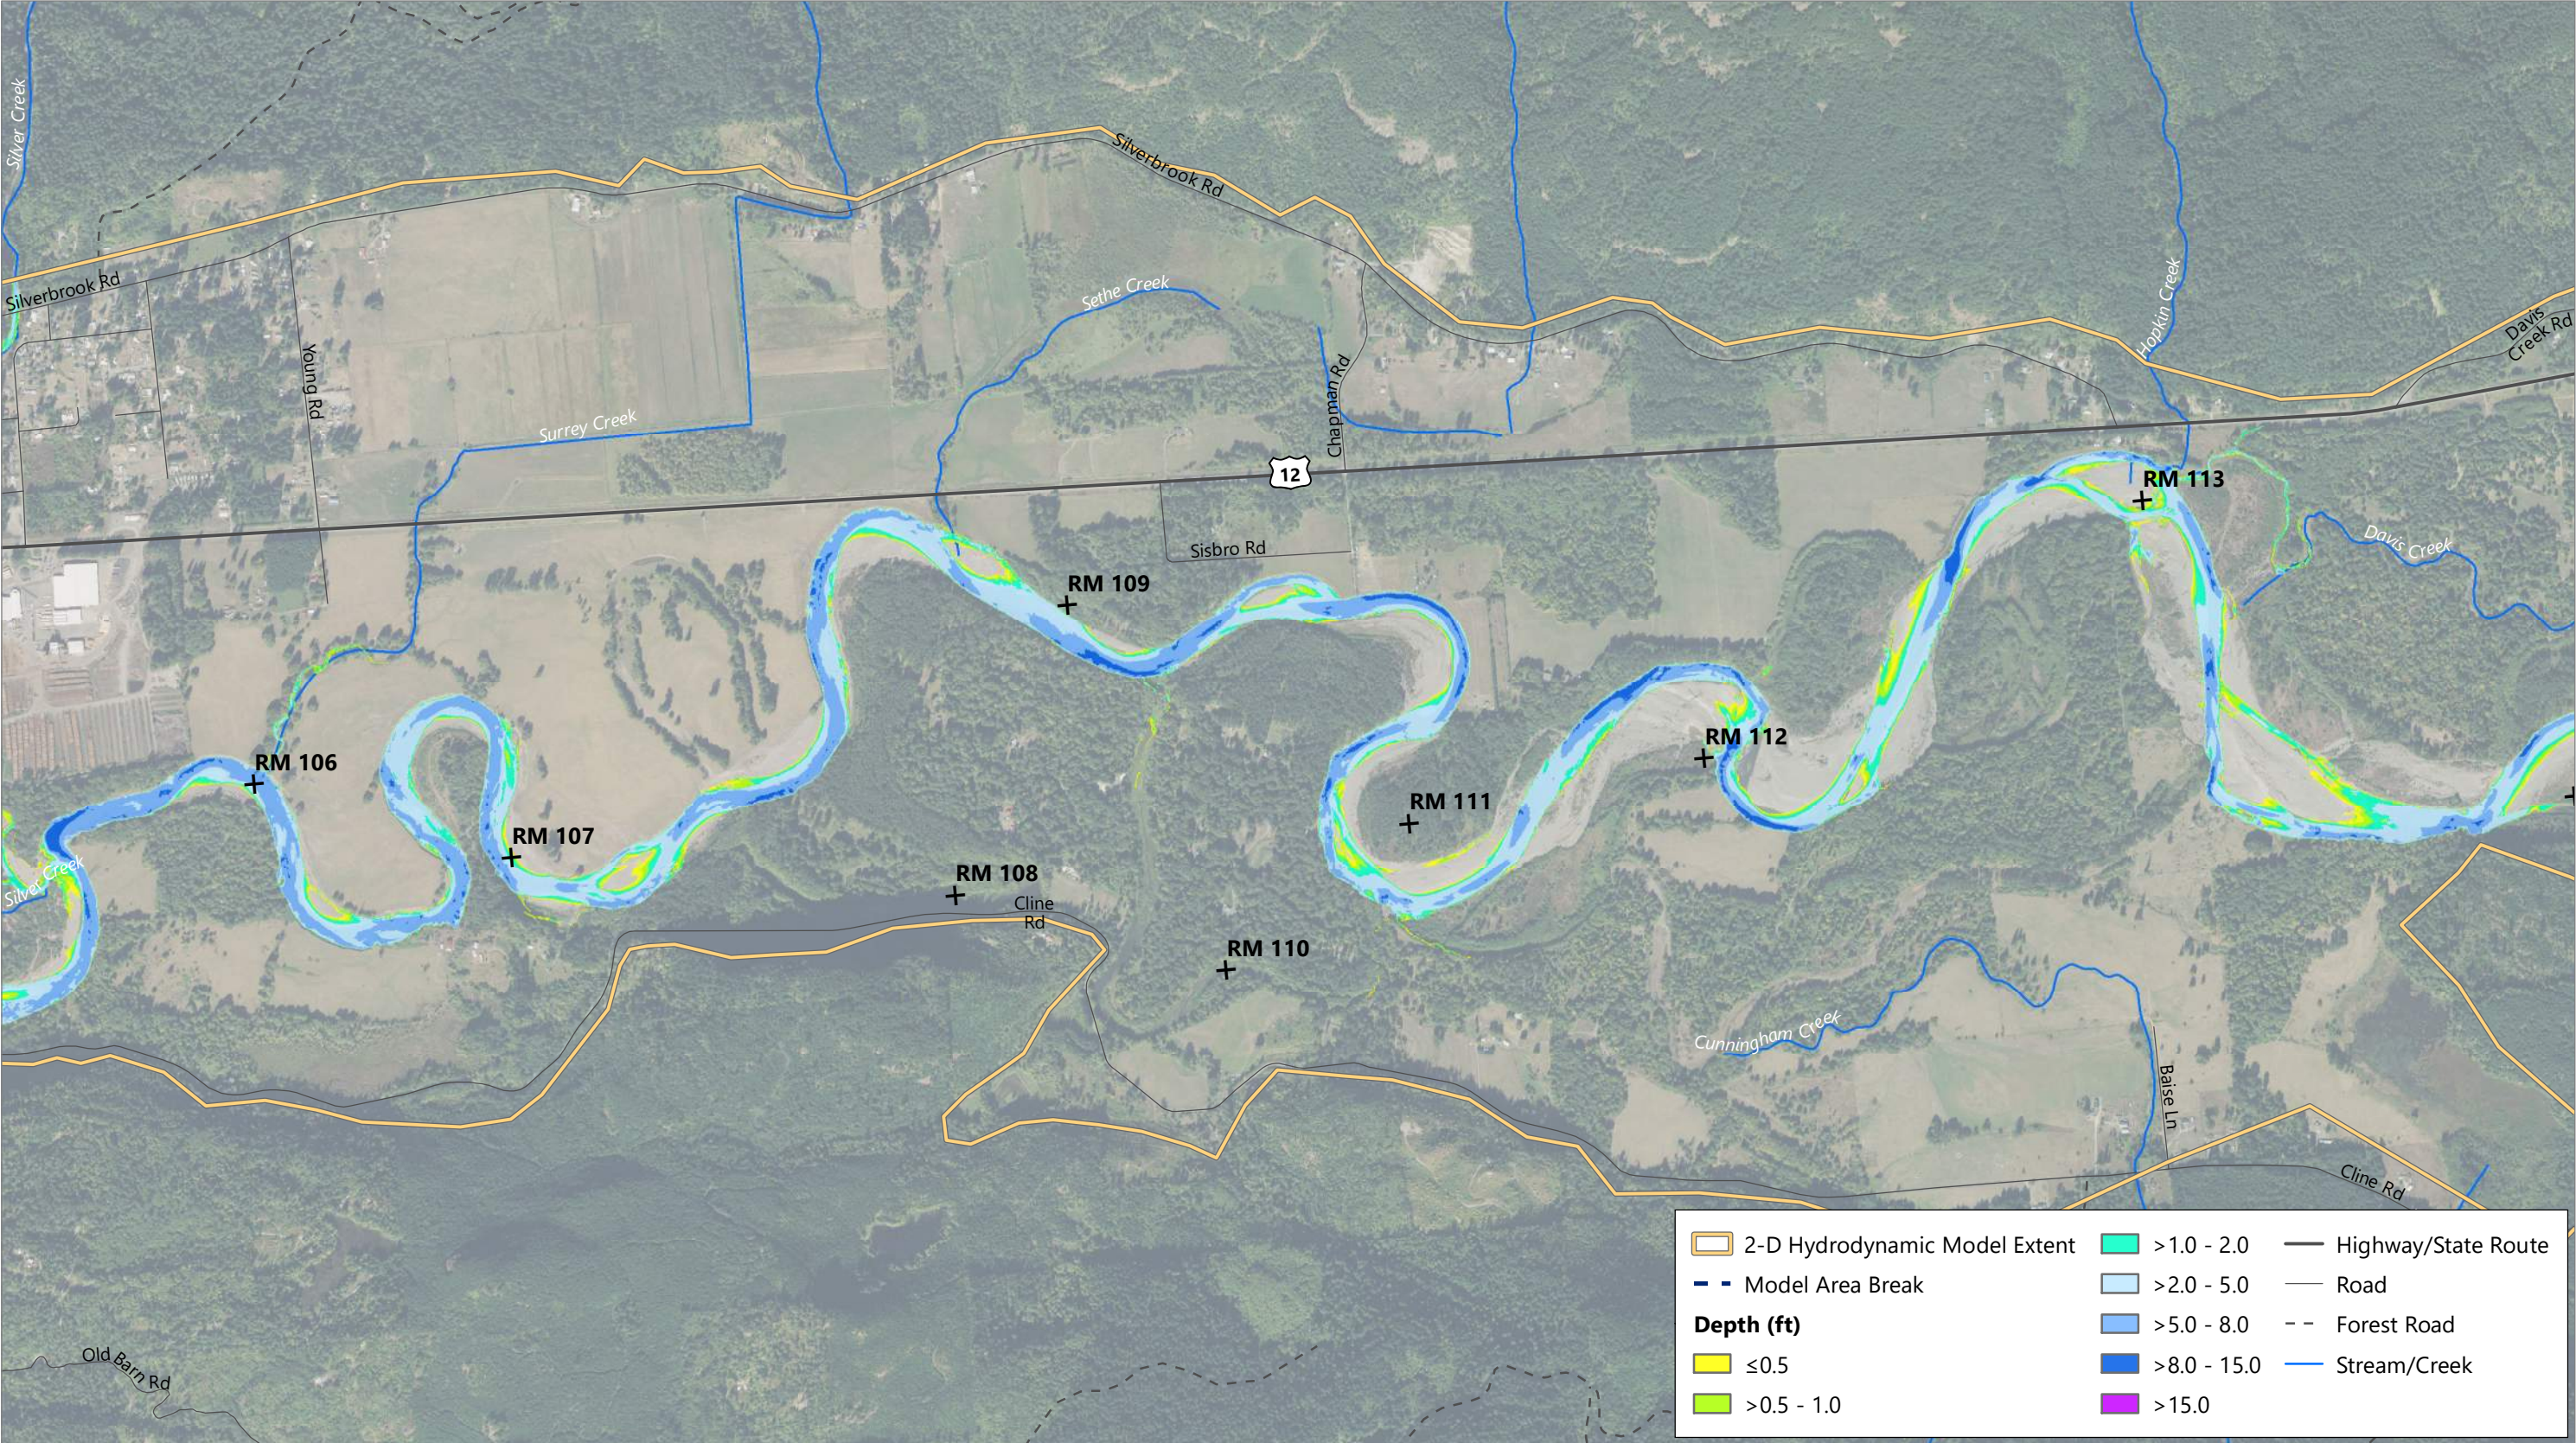
Figure 2
Winter Average High Flow Depth
Cowlitz River Restoration

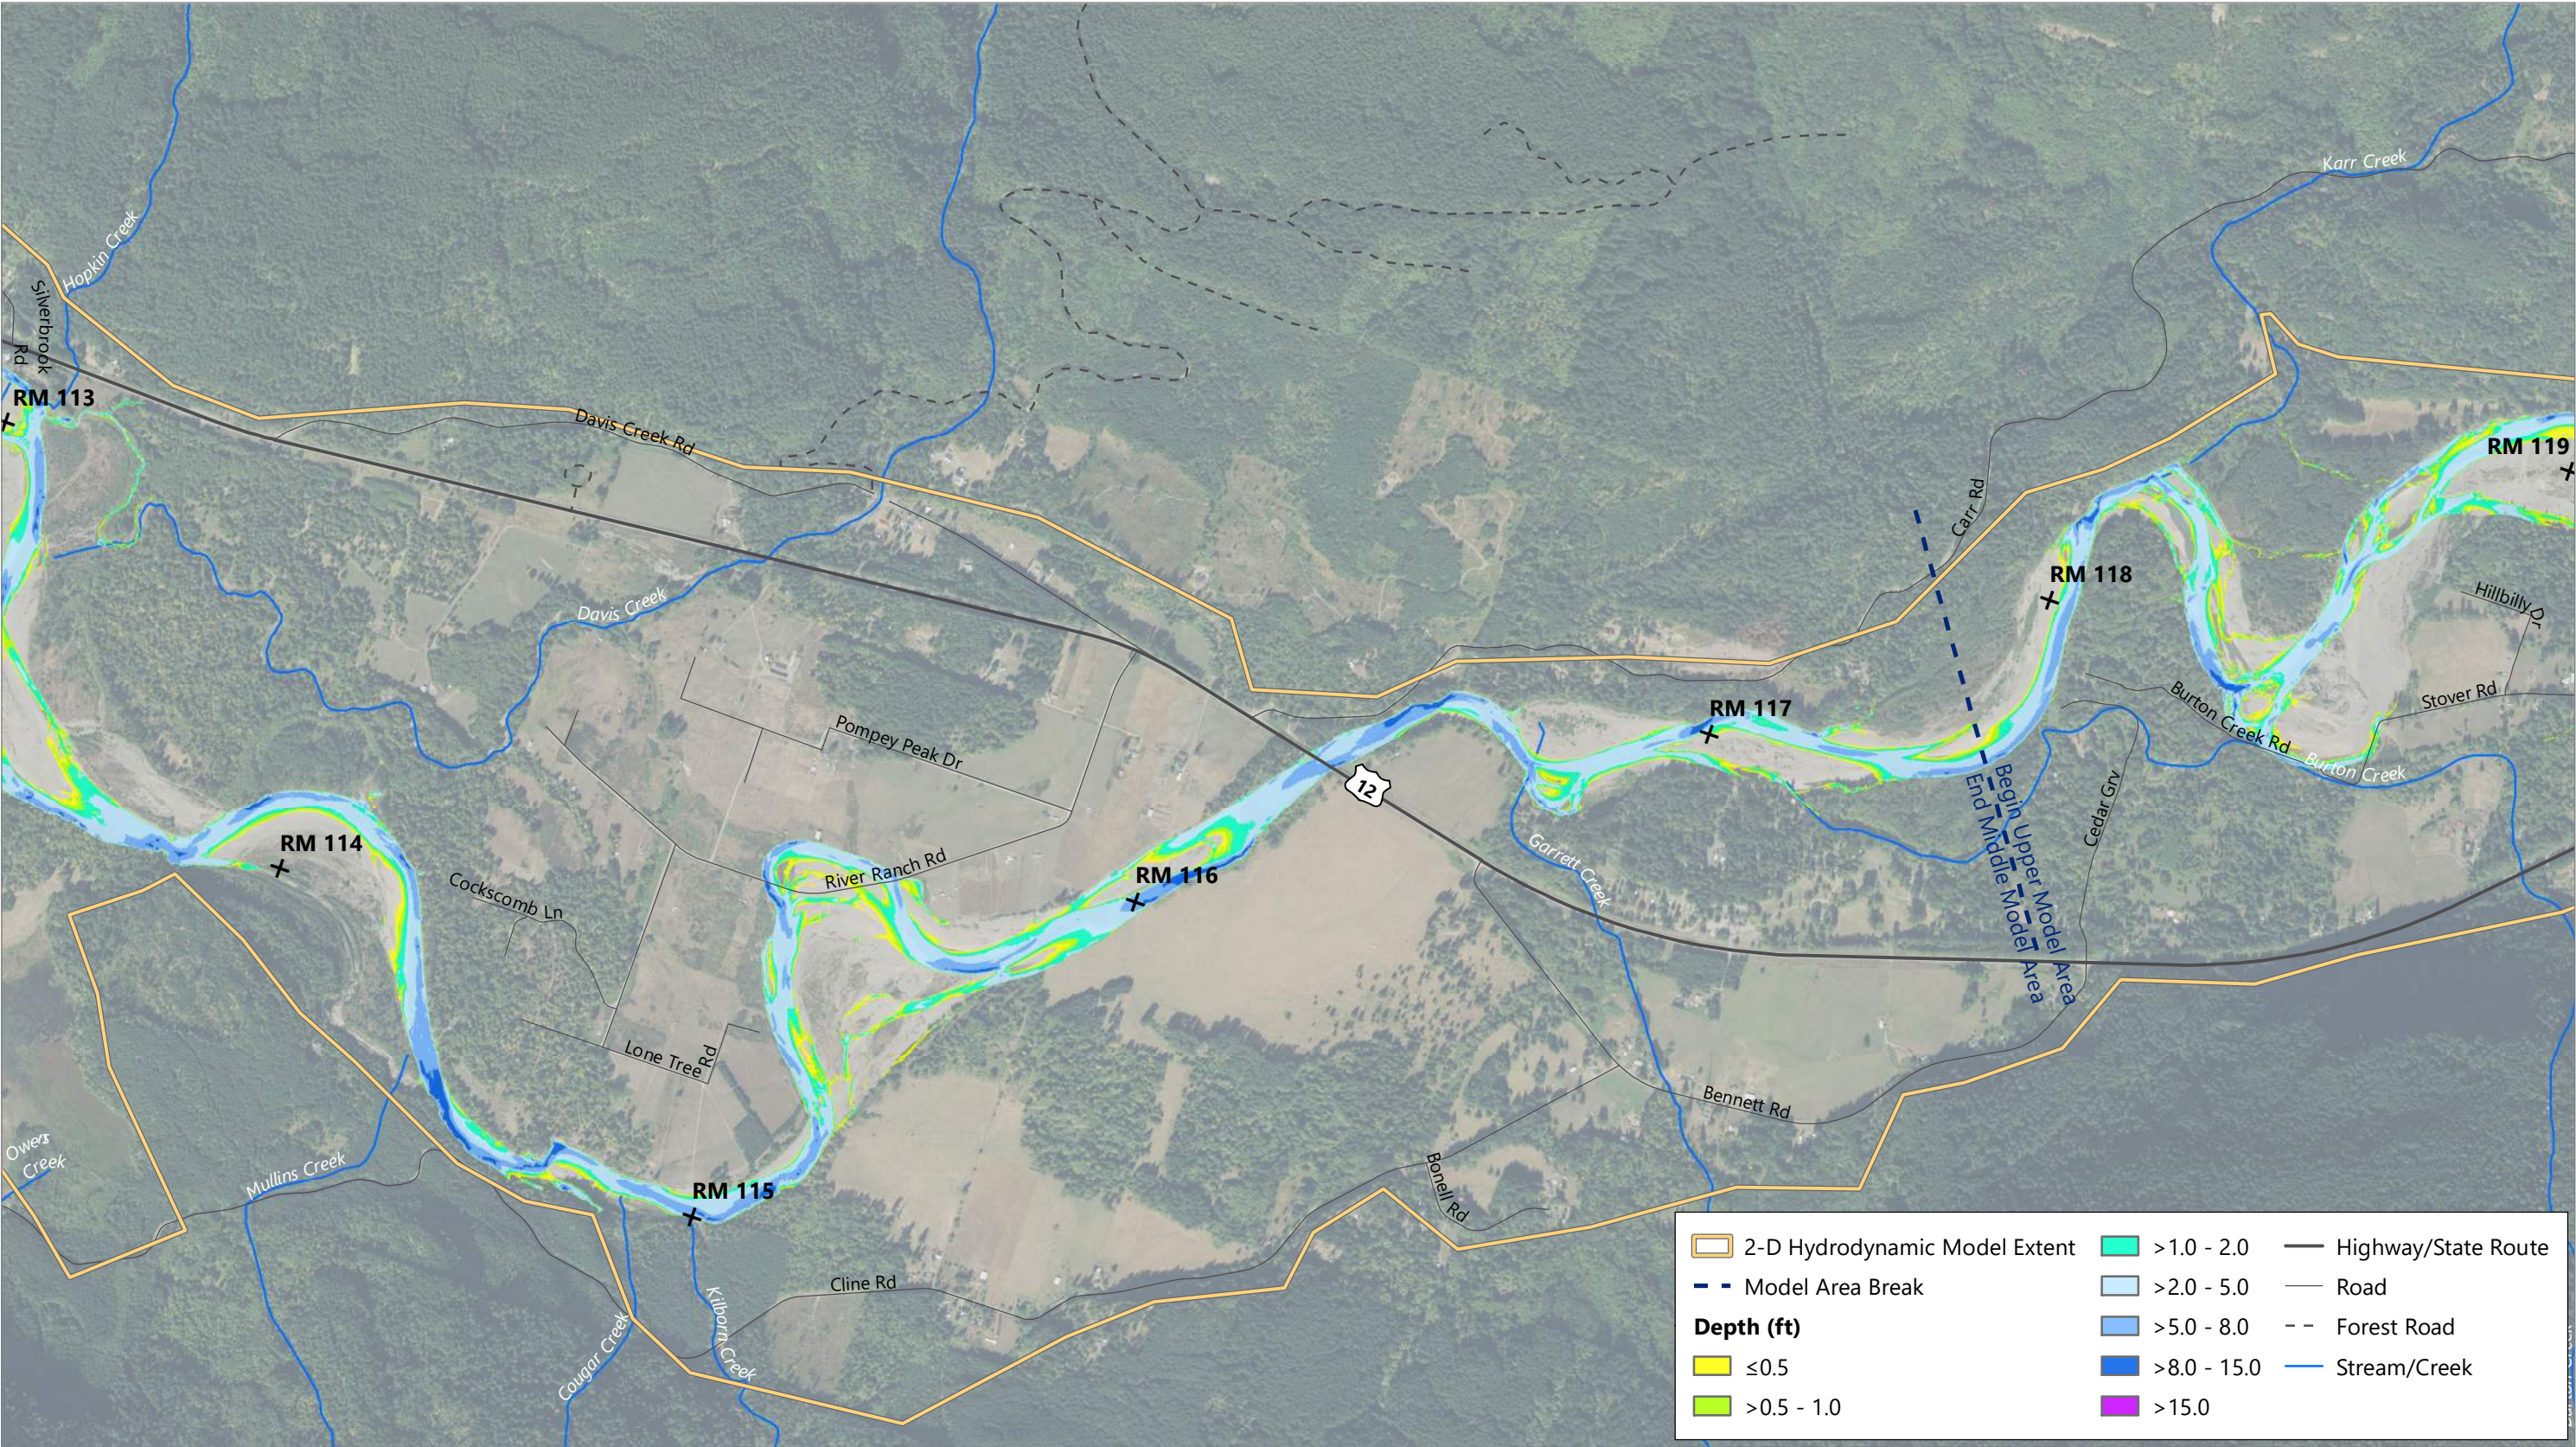
Figure 3
Winter Average High Flow Depth
Cowlitz River Restoration

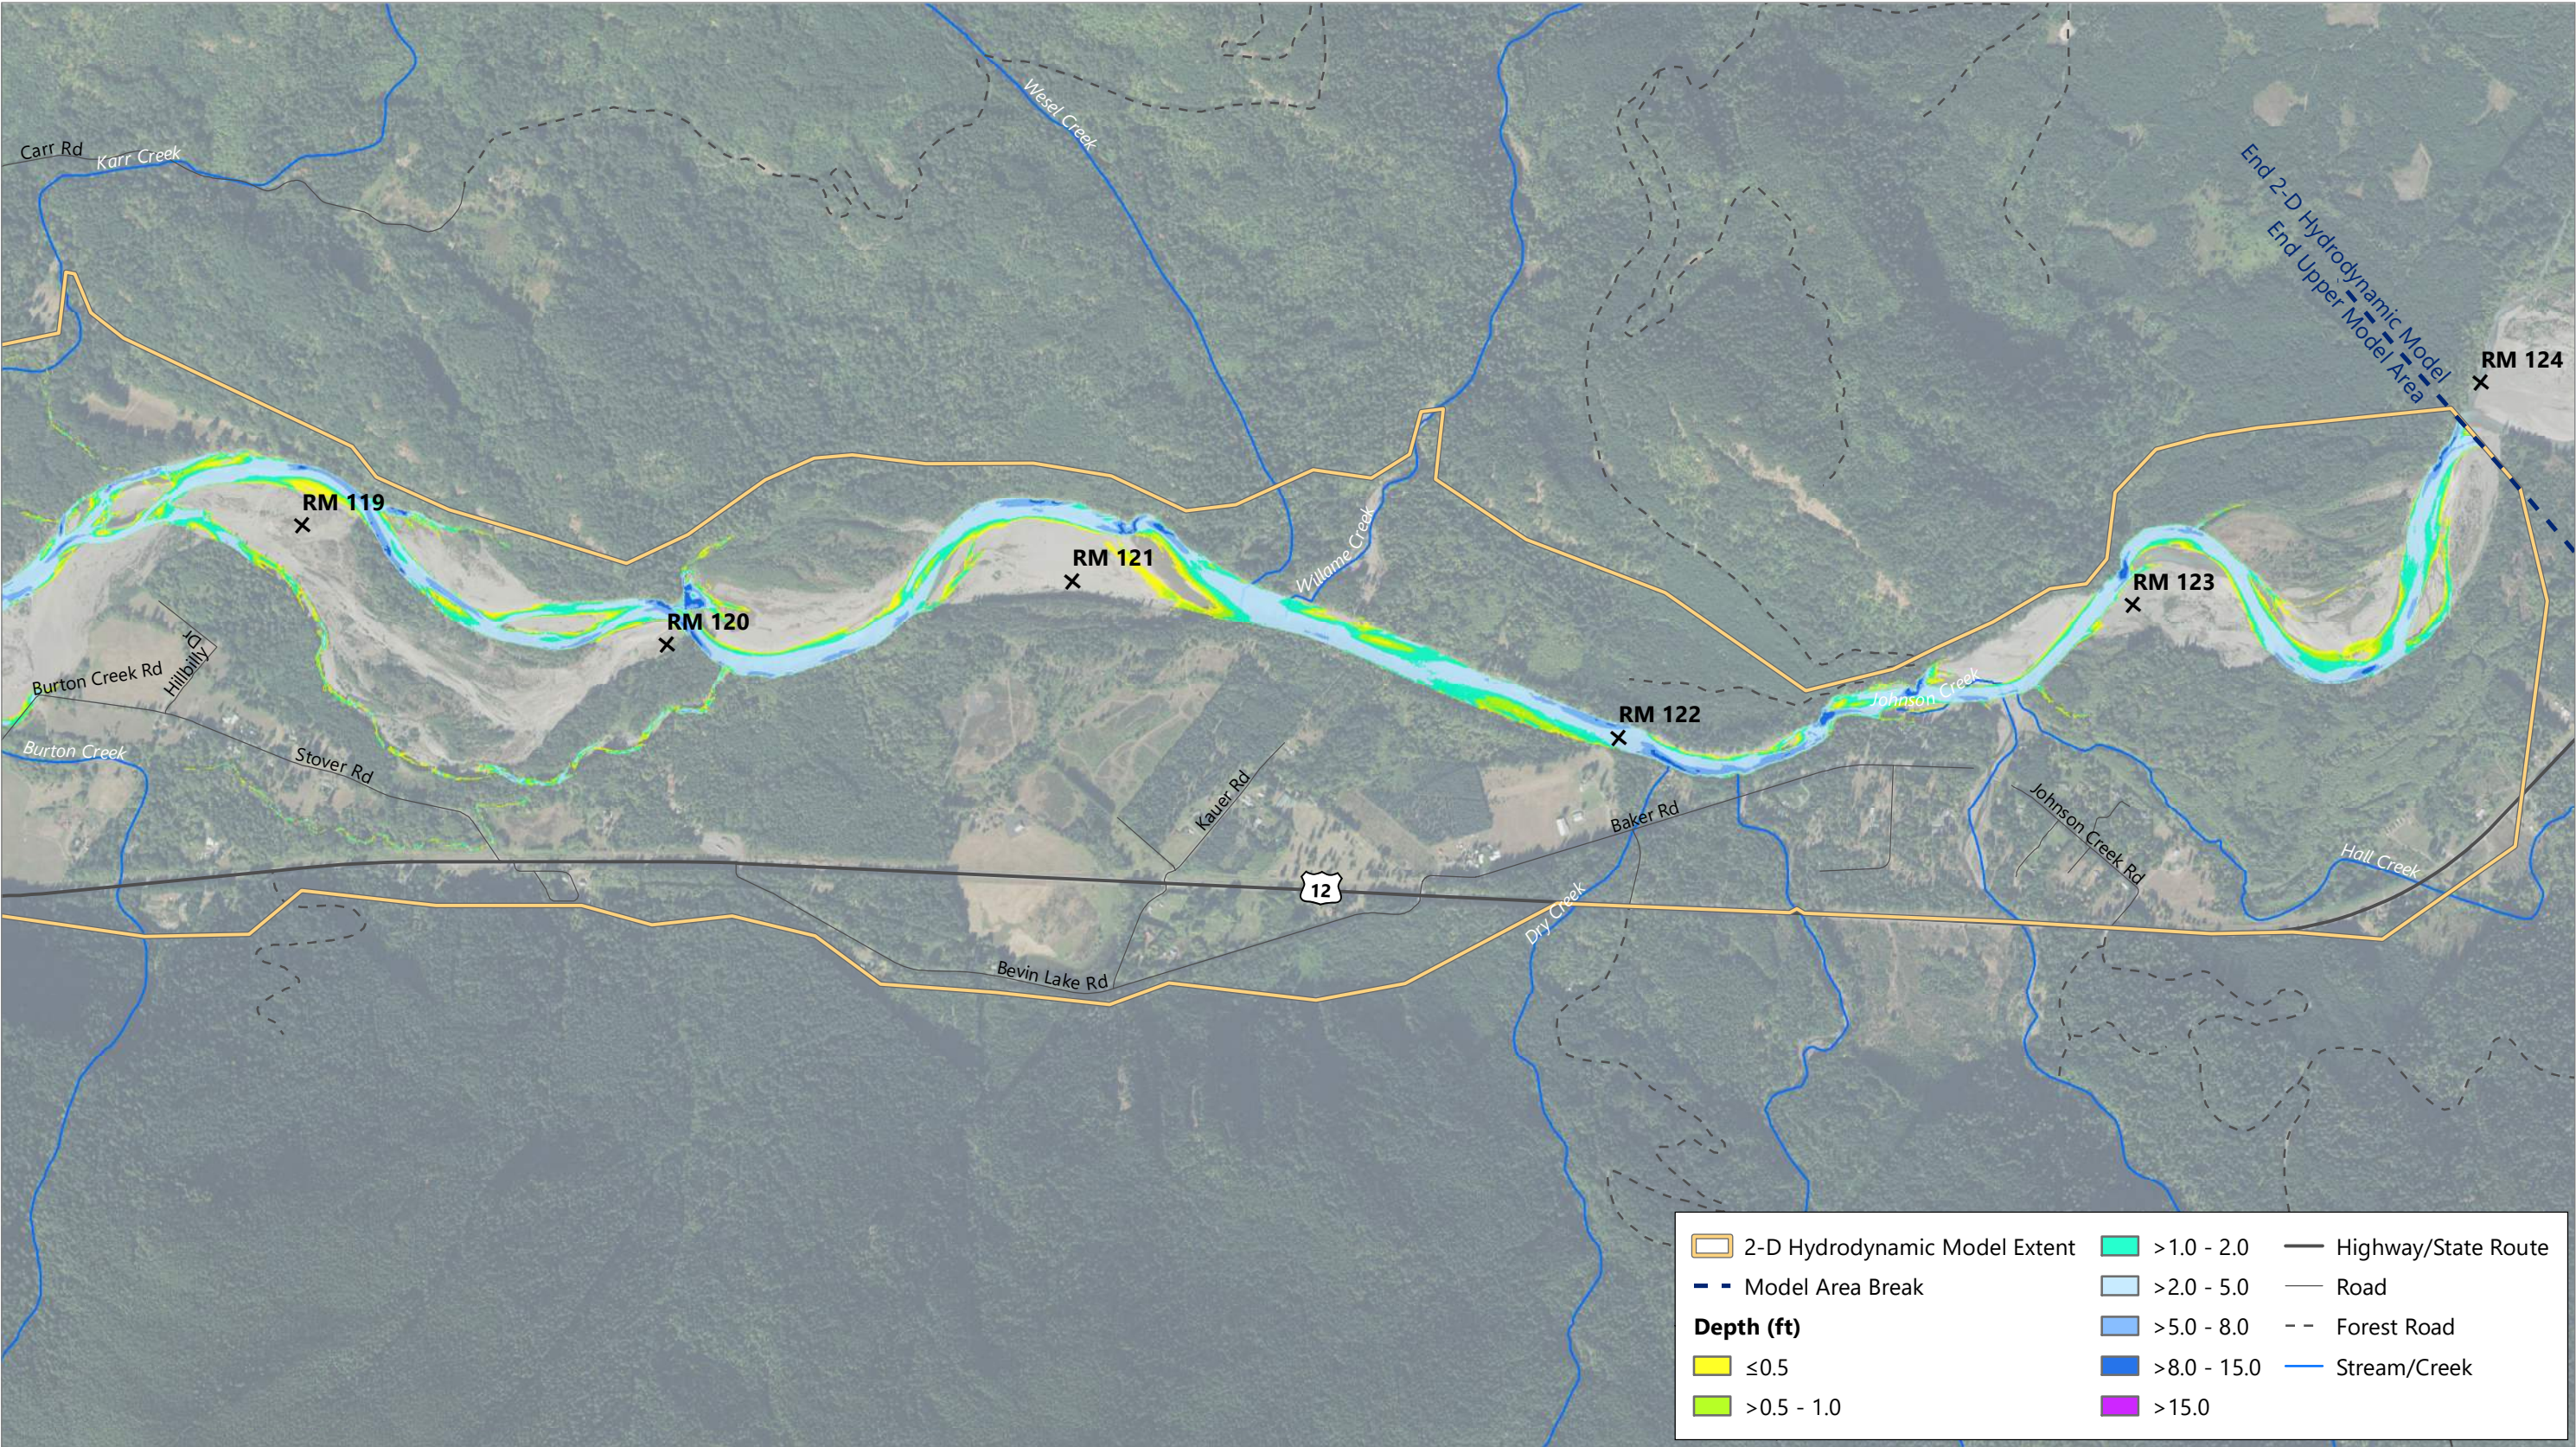
Figure 4
Winter Average High Flow Depth
Cowlitz River Restoration
