**Figure 1**  
**Winter Average High Flow Velocity**  
Cowlitz River Restoration

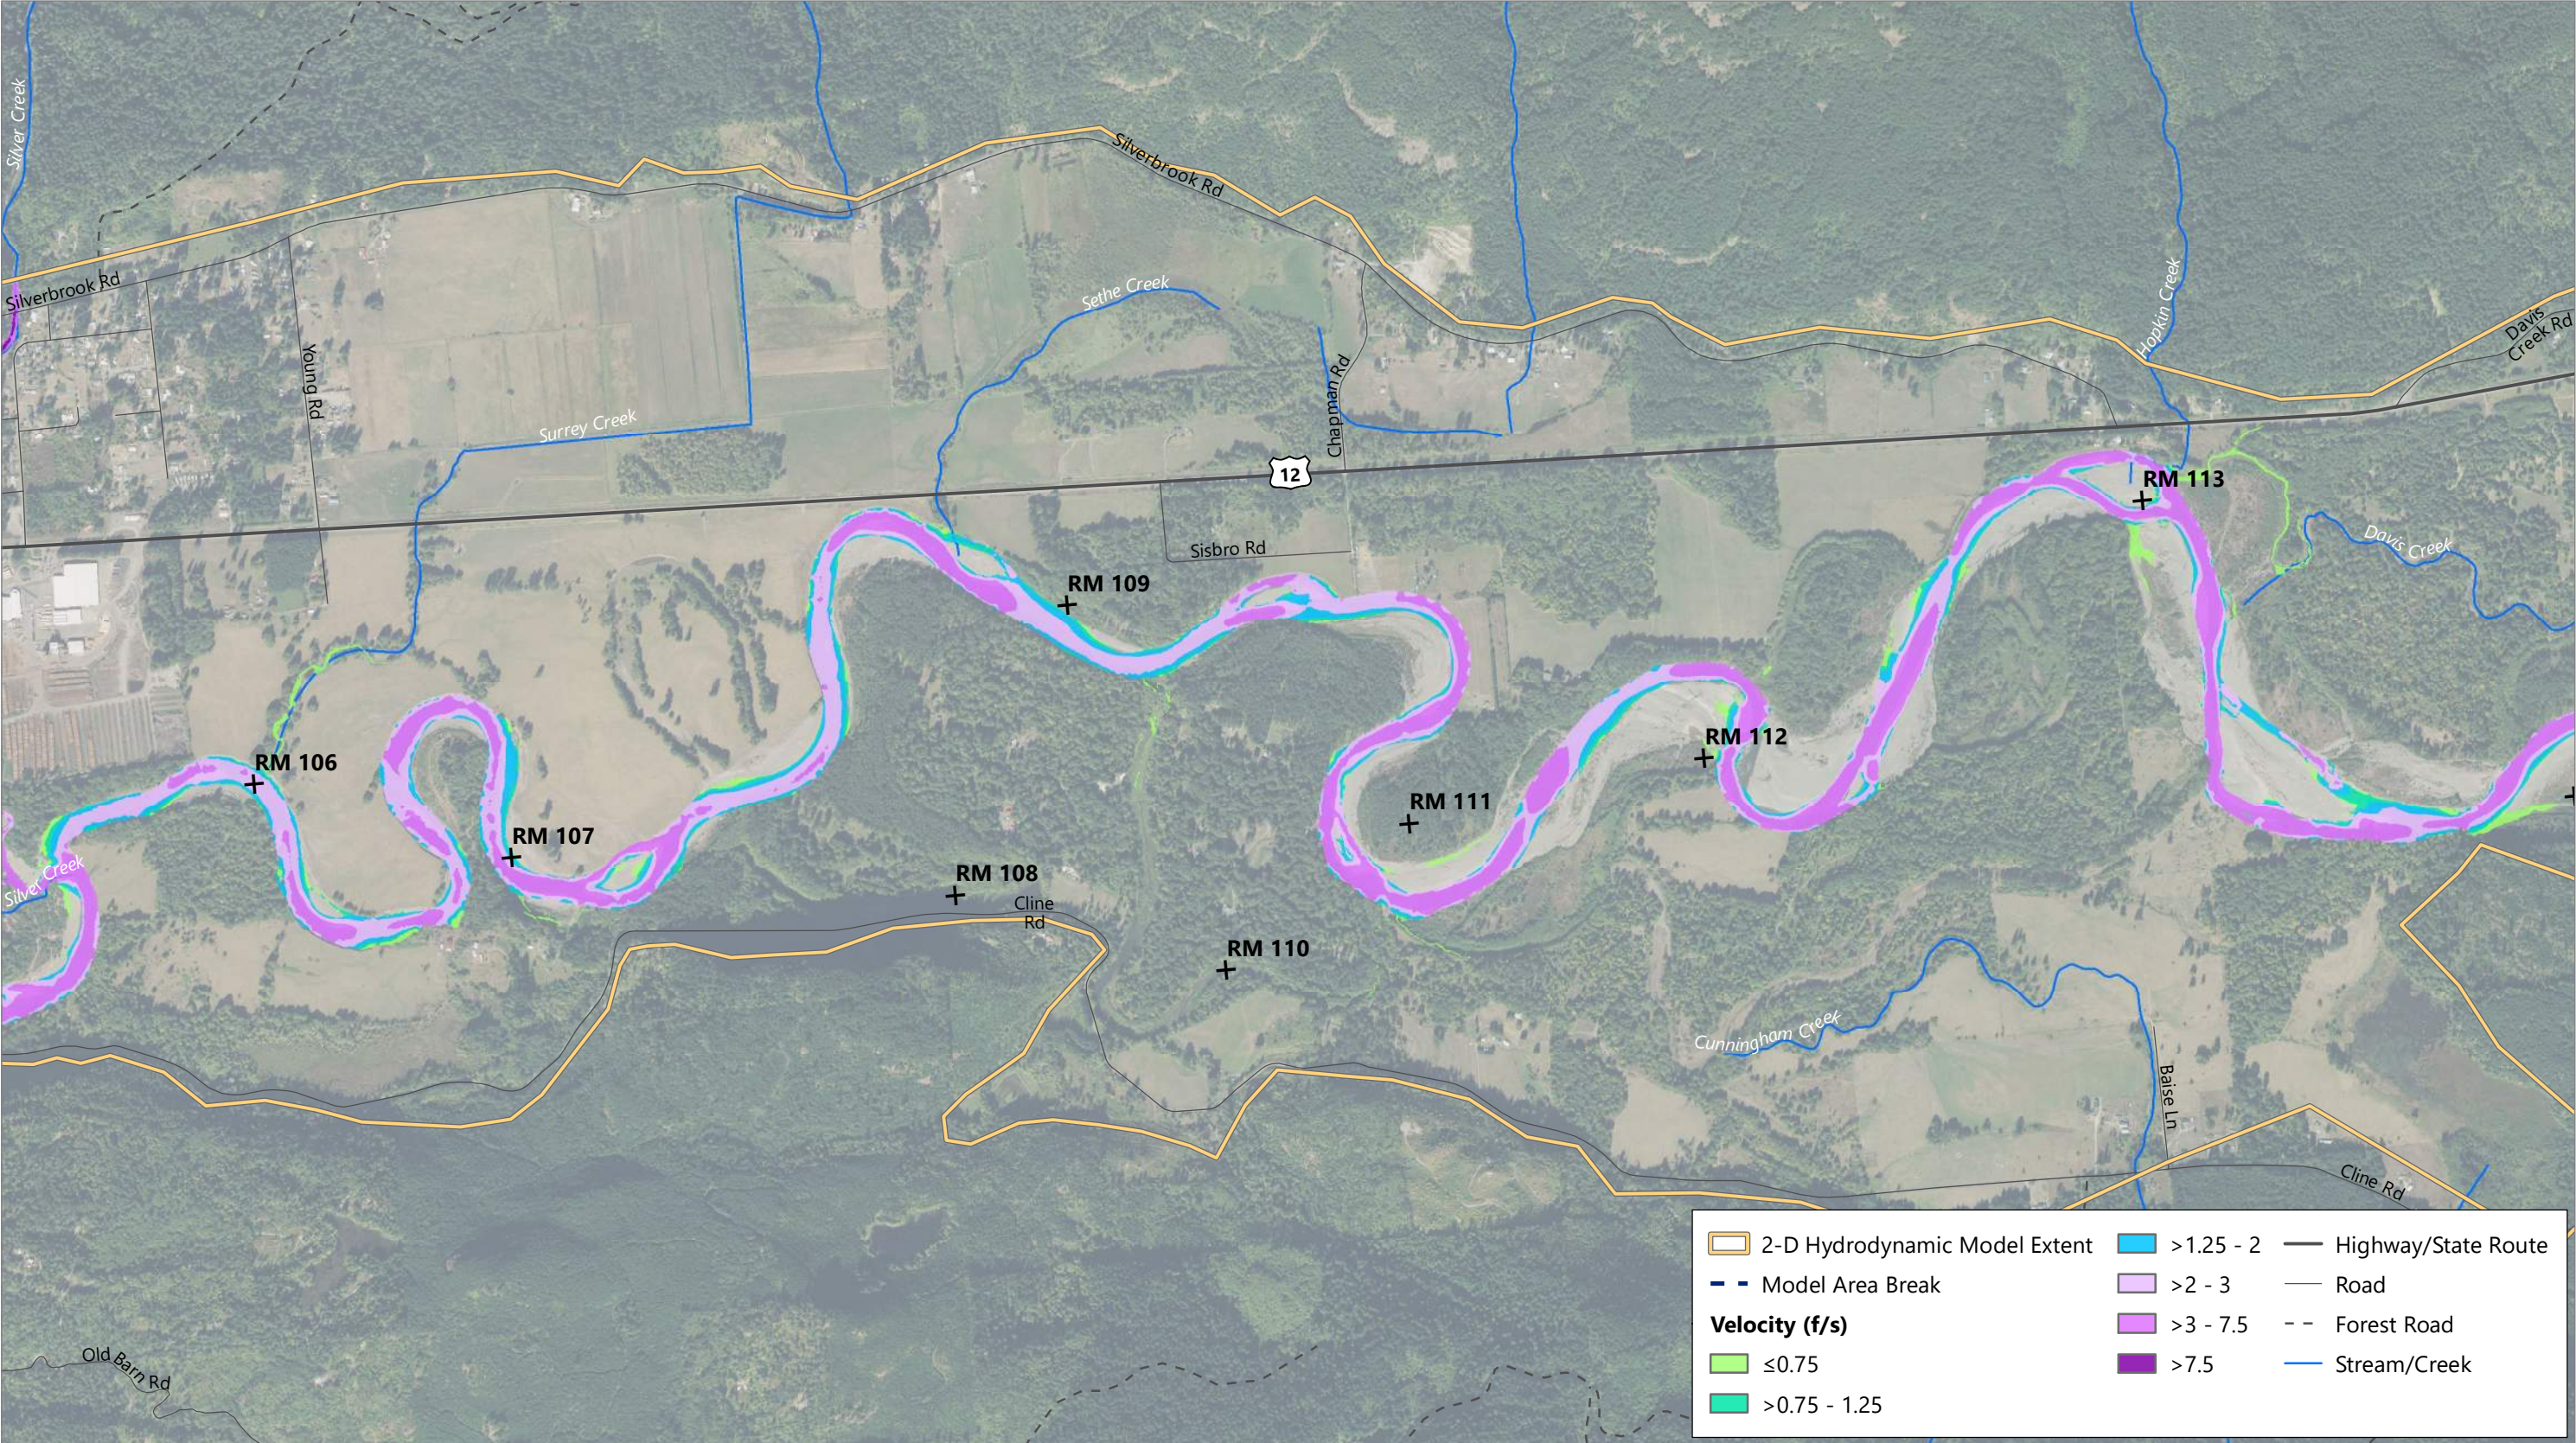
**Figure 2**  
**Winter Average High Flow Velocity**  
Cowlitz River Restoration

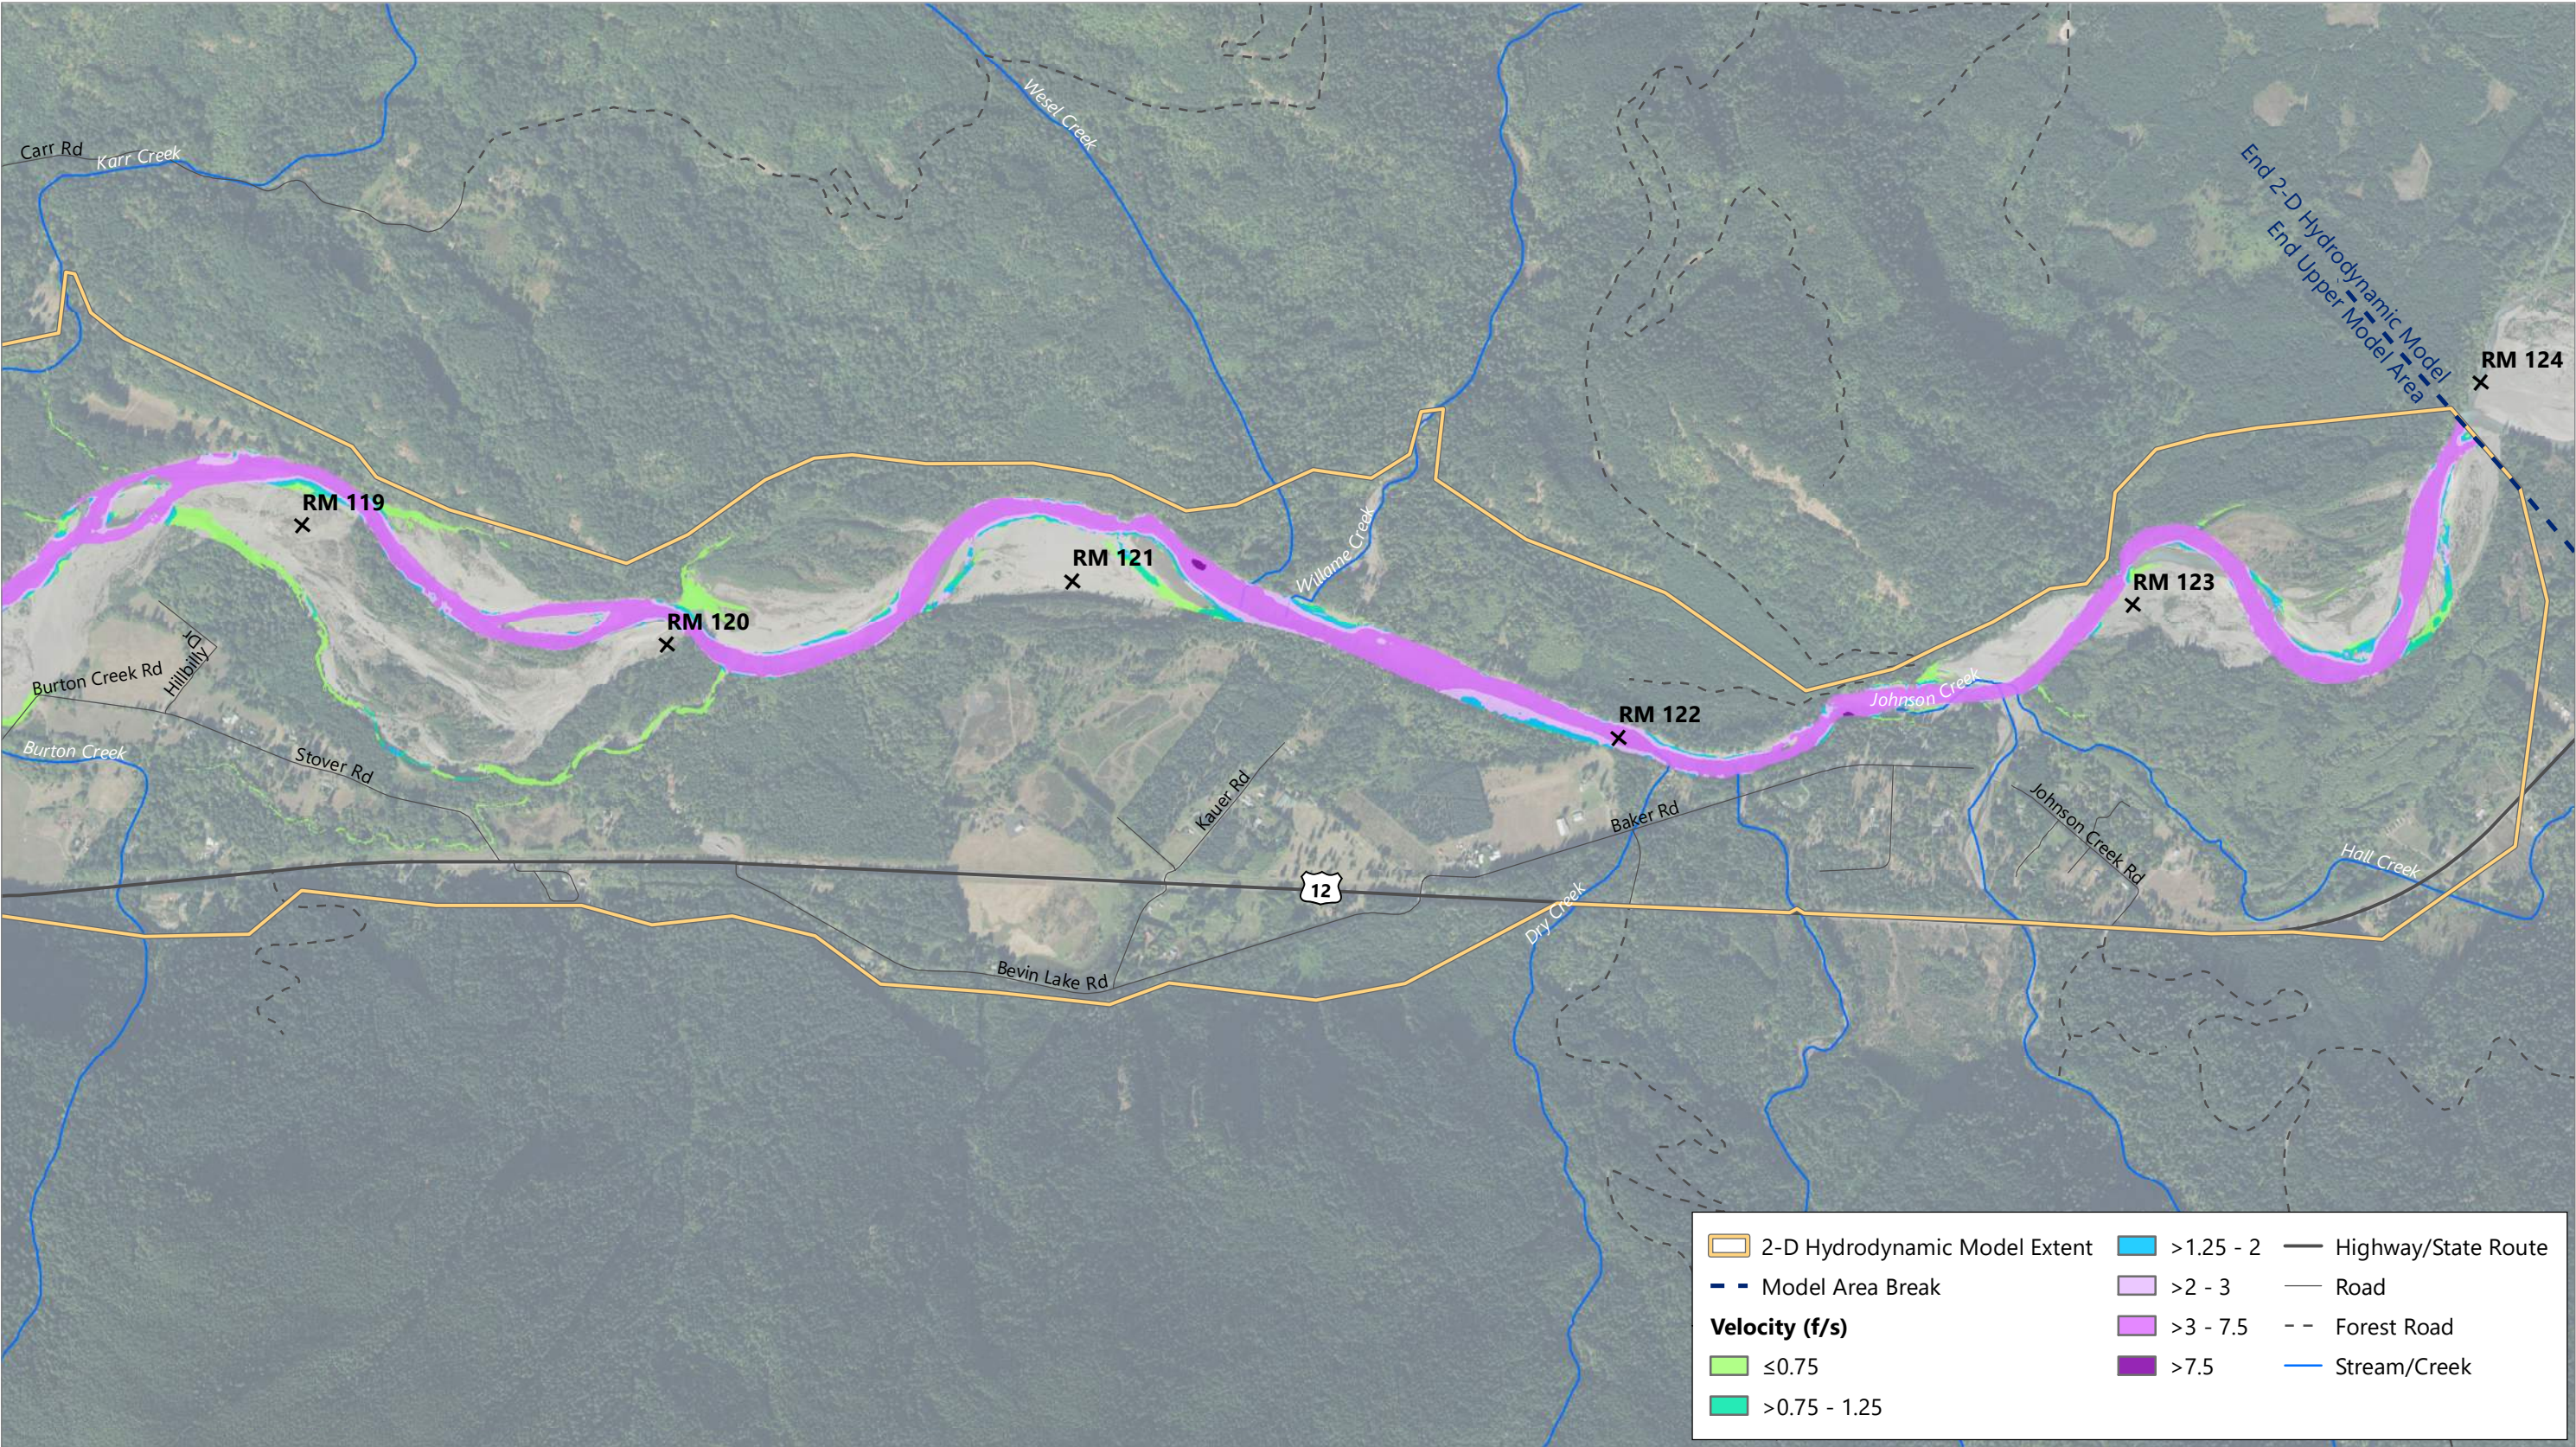
**Figure 4**  
**Winter Average High Flow Velocity**  
Cowlitz River Restoration
