LEAD GOOSENECK REPLACEMENT PROJECT COMPLETION

JONATHAN SCHLAUDRAFF
SYSTEM PLANNING

JUNE 2021

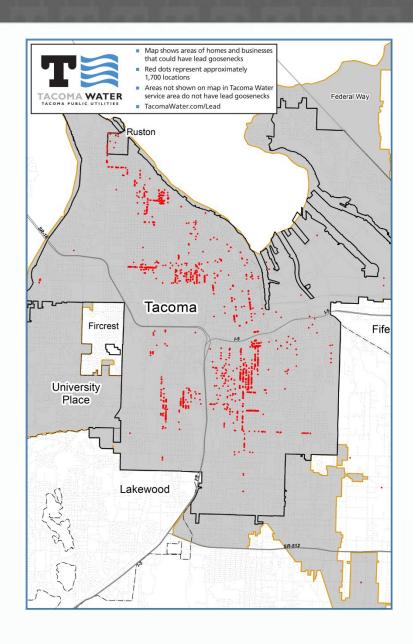
POTENTIAL GOOSENECK SELECTION PROCESS

POTENTIAL LEAD GOOSENECK LOCATIONS (TACOMA'S CRITERIA)

Services that were:

- 2-inches or smaller AND
- Classified in records as "galvanized", "unknown", or "blank" AND
- Installed earlier than 1940 AND
- Installed on mains that were older than 1940 AND
- Where no service renewal had occurred beyond this timeframe

Note: Dates prior to 1940 selected to allow 10 years beyond oldest known lead gooseneck installation in Tacoma (1929)

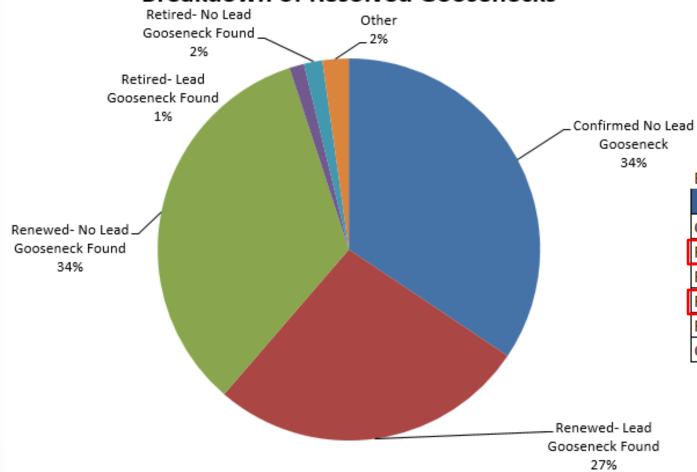
Breakdown of Resolved Goosenecks

Breakdown of Resolved Goosenecks	Quantity	Percent
Confirmed No Lead Gooseneck	418	34%
Renewed- Lead Gooseneck Found	327	27%
Renewed- No Lead Gooseneck Found	409	34%
Retired- Lead Gooseneck Found	15	1%
Retired- No Lead Gooseneck Found	19	2%
Other	27	2%
Total	1,215	100%

- 1,215 total potential goosenecks resolved
 - 736 services replaced (61% of total)
 - 342 lead goosenecks found and removed (28% of total)
- ESTIMATED REMAINING SPENDING: \$705K
 - Concrete paving contract with Public Works

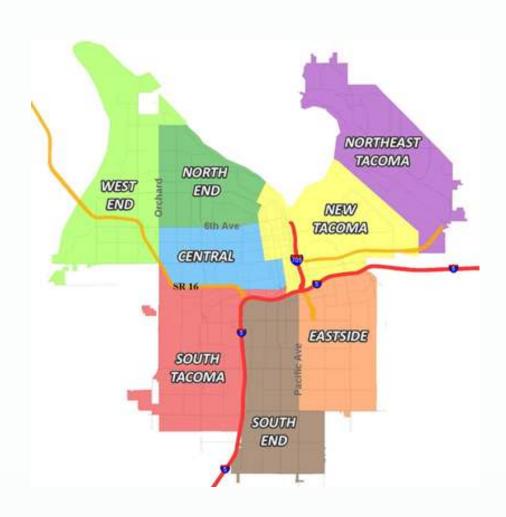
2. COMPLETE WORK IN A GEOGRAPHICALLY EQUITABLE MANNER

- EVENLY DISTRIBUTED THROUGH TIME
- EQUITABLY DISTRIBUTED GEOGRAPHICALLY (8 NEIGHBORHOOD DISTRICTS)
- PROJECT BLOCKS:
 - City Pavement Restoration Policy
 - Pavement Condition
 - Project Coordination

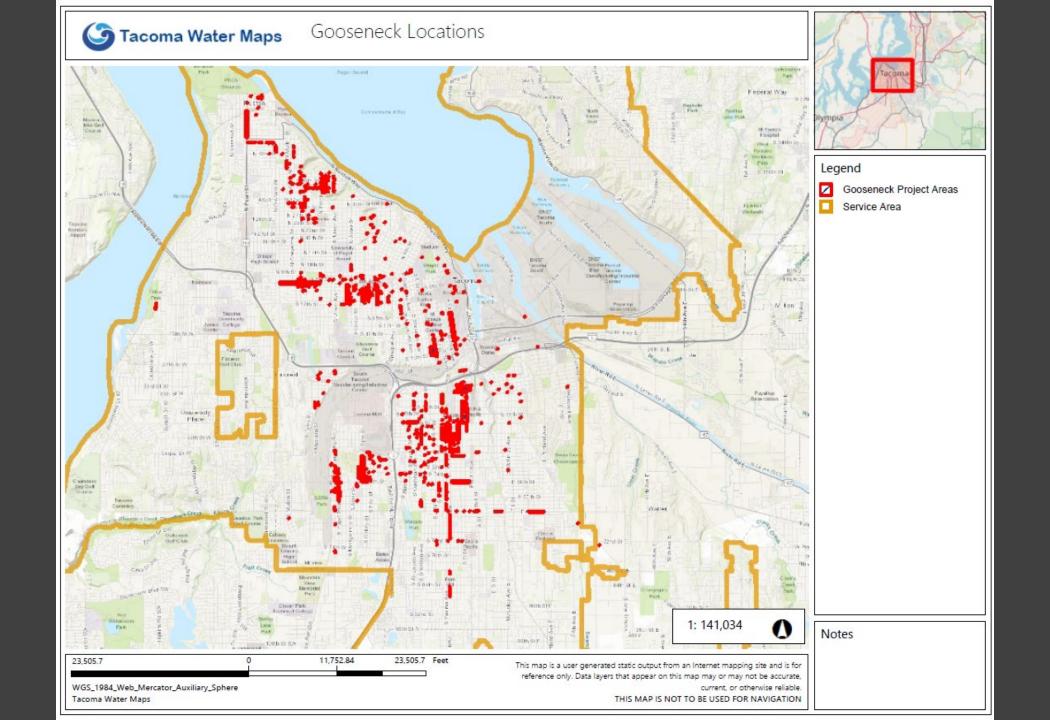
LEAD LOCATIONS & EQUITY INDEX

Potential Goosenecks

Low Moderate High

Percent 43% 26% 31%

Lead Found

Percent 54% 36% 10%

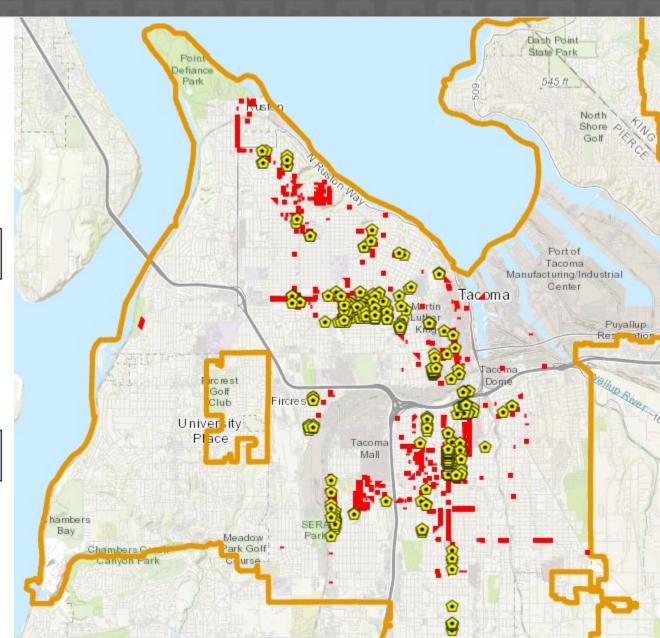
COMPARING WORK COMPLETED TO EQUITY INDEX

- LOW SCORED AREAS COMPLETED EARLIER
- MOST 2020 AND 2021
 SERVICES TIED TO PUBLIC
 WORKS CONCRETE PAVING
 CONTRACTS OR MAIN
 REPLACEMENT PROJECTS
