#### 2018 Water System Plan, Tacoma Water

### Chapter 6, Appendix I: Distribution System Analysis

## Chapter I4. Technical Memo (RH2, 9/20/2017), Hydraulic Model Updates

Client:	Tacoma Water		
Project:	Hydraulic Model Update and	d Calibration	
Project File:	TAC 517.122.01.102	Project Manager:	Michele Campbell, PE
Composed by:	Ryan Withers, PE		
Reviewed by:	Geoff Dillard, PE		
Subject:	Stage 1 Updates		
Date:	September 20, 2017

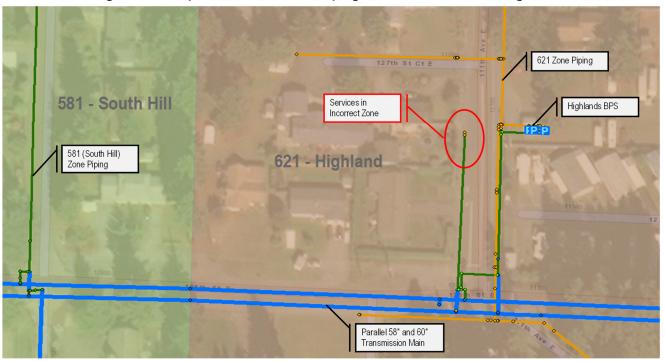
Figure 1: Example of Junctions and Piping with Incorrect Zone Assignments

While the six Stage 1 updates were being performed in the hydraulic model, RH2 identified numerous junctions and pipes with pressure zone assignments that differed from the actual pressure zone they actually convey water to. One example of this occurs near the intersection of 111<sup>th</sup> Avenue E and 128<sup>th</sup> Street E near the boundary between the 621 (Highland) Zone and the 581 (South Hill) Zone. Junctions on the west side of 111<sup>th</sup> Avenue E, directly west of the Highland BPS, are assigned to the 621 Zone, but are actually served by the 581 Zone, as shown in **Figure 1**.

It is outside RH2's scope of work to resolve pressure zone discrepancies similar to those shown in **Figures 1** and **2** throughout the hydraulic model. Junctions with an incorrect pressure zone assignment may erroneously limit or over-report the fire flow availability throughout the pressure zone; therefore, it is recommended that Tacoma Water review the pressure zone assignments for junctions and pipes as part of the fire flow analyses to be set up and performed by Tacoma Water for inclusion in Tacoma Water's 2017 *Water System Plan*. Additionally, some junctions within the distribution system do not have pressure zone assignments. It is recommended that Tacoma Water include a pressure zone assignment for every junction in the model, including any additional junctions requiring a "no services" or "facility" assignment.

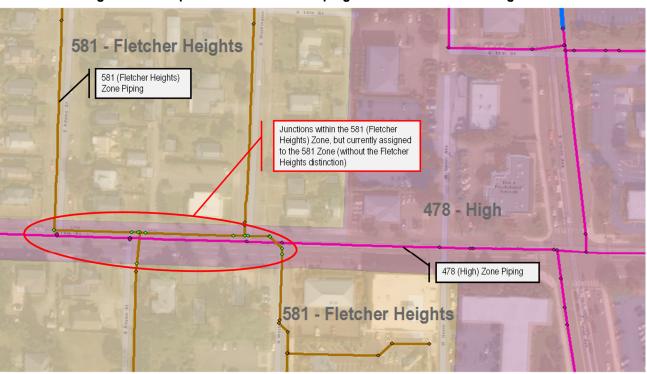
Another example of pressure zone assignments recommended for additional review by Tacoma Water include pressure zones with the same hydraulic grade that are physically disconnected. The Tacoma Water distribution system provides service to multiple pressure zones with a 581-foot hydraulic grade. The pressure zone assignments for the junctions in these zones typically are indicated with a descriptor, such as "581 SE Tacoma" or "581 Fletcher Hts." However, there are instances wherein the 581 Zone assignments are incorrect. One example of this occurs along S 19<sup>th</sup> Street, west of the intersection with S Union Avenue near the boundary between the 581 (Fletcher Heights) Zone and the 478 (High) Zone, as shown in **Figure 2**. Junctions in the 581 (Fletcher Heights) Zone are properly assigned on either side of S 19<sup>th</sup> Street, but the junctions within S 19<sup>th</sup> Street currently have a "581" pressure zone assignment; therefore, they would not be considered as part of the minimum pressure check during fire flow analyses for the 581 (Fletcher Heights) Zone.

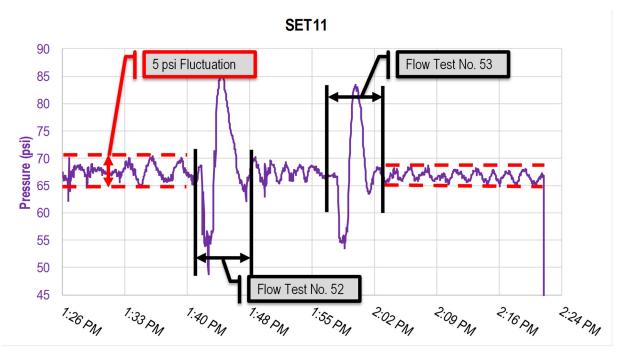
**Chart 1: SET11 Pressure Transducer Data**

The 520 SE Tacoma Zone is a closed zone served by a PRV station. Pressure transducers indicate that a pressure fluctuation of approximately 5 psi is occurring every 1 to 2 minutes in the 520 SE Tacoma Zone during static conditions, as shown in **Charts 1** and **2**. The location of these transducers, SET11 and SET12, are shown in **Figure 5**. It is recommended that the setpoint and operation of the PRV station serving the 520 SE Tacoma Zone be evaluated to confirm proper operation and possibly reduce the pressure fluctuation that was observed to be occurring during static conditions.

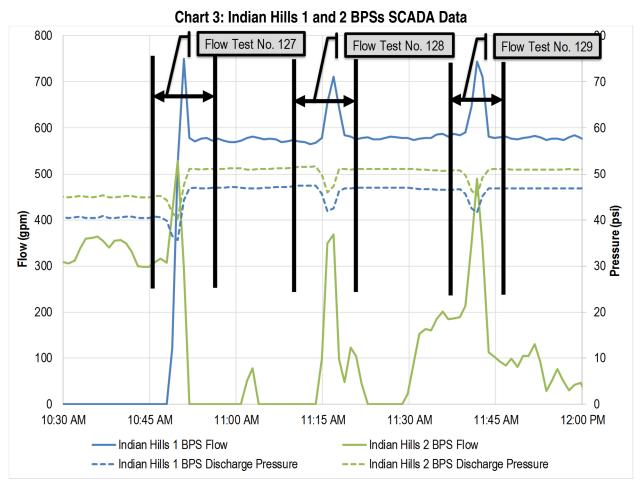
As described in the **NE Tacoma Area** calibration summary, the 649 Indian Hills Zone is a closed zone served by two BPSs, and the hydraulic grade of the pressure zone fluctuates depending on the supply rate of the two BPSs. The SCADA data from the day of field testing for Flow Test Nos. 127, 128, and 129 is shown in **Chart 3** for each BPS. As shown in **Chart 3**, the pressure during non-flow test periods ranged from approximately 45 to 51 psi at the Indian Hills 1 BPS, and ranged from approximately 40 to 47 psi at the Indian Hills 2 BPS. Additionally, during Flow Test Nos. 127, 128, and 129, the pressure at the Indian Hills 1 and 2 BPSs decreased by approximately 5 psi compared to the pressure during non-flow test periods. This decrease in pressure indicates that additional pumps were not called to operate, and the pumps that were operating were moving "to the right" on the pump curves to meet the normal demand and hydrant demand in the zone while reducing the hydraulic grade of the zone. Depending on any building-specific fire flow or level-of-service requirements in the 649 Indian Hills Zone, it may be necessary to adjust the pump setpoints to allow increased flow to be provided from the Indian Hills 1 and 2 BPSs without reducing the hydraulic grade of the zone.

- d. Flow Test Nos. 127 through 129: When only the Indian Hills 2 BPS is operational (i.e., all pumps at the Indian Hills 1 BPS are off), the hydraulic grade of the 649 Indian Hills Zone decreases 16 feet, from 649 to 633 feet. Controls were added to the pressure sustaining valve in the Indian Hills 2 BPS to reflect this condition. Additionally, the Indian Hills 1 and Indian Hills 2 BPSs were cycling on and off during these flow tests. Based on the SCADA data provided by Tacoma Water, the status of each of these BPSs during these flow tests is shown in **Table 4**.
