TACOMA WATER DIVISION

Report Date: October 16, 2013

DOH System ID	86800 N	Survey Dates	8/9/13 – 8/12/13
System Type	Group A Community	Operating Permit	Green
Surveyor	John Ryding

Tacoma Water's Fletcher Heights Reservoir

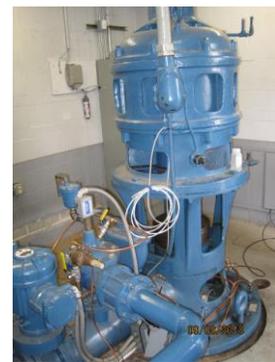
blends, or uses entirely, water from their North Fork wellfield located in the Green River watershed. The practical well capacity (not including North Fork wells) maintained by Tacoma Water is unchanged at approximately 50 MGD (Well #4A pictured). These wells can supply the utility's service area west of the McMillin Reservoir and are often used in the summer to supplement the Green River source during periods of high demand.

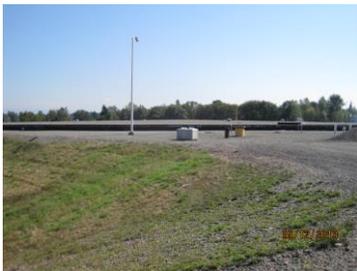
Tacoma Water maintains a total storage capacity of approximately 128 million gallons (Portland Avenue Reservoir pictured). Since the previous survey the two North basins of the uncovered McMillin reservoirs (110 million gallons) have been disconnected from the distribution system and replaced with two 33-million gallon prestressed concrete reservoirs. This has reduced Tacoma Water's storage capacity by approximately 40 million gallons but their most recent Water System Plan update, approved in 2008, indicated that the utility has adequate storage capacity with the completion of the covered reservoirs. Tacoma Water plans to build a third 33-million gallon reservoir at the McMillin site as funds allow and water demands require.

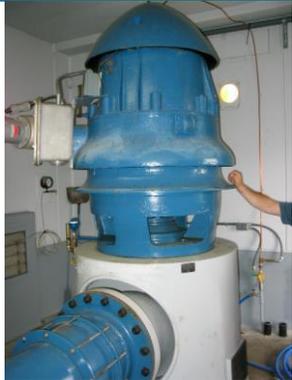
<p>11A</p>	<p>This is the largest producer of the South Tacoma Wells with a production rate of approximately 9,000 gpm at startup. The well draws from a shallow aquifer and, by itself, can only be operated for 10 days at a time followed by a 10 day resting period due to the influence of the Time Oil hazardous waste site. The well can be run for longer periods of time if Well 12A is run at the same time. There have been a number of historical samples from the well with detectable VOCs. An inverted goose neck was installed on the air vent during the survey. There is an adequate air gap and screening on the pump waste blowoff line.</p>

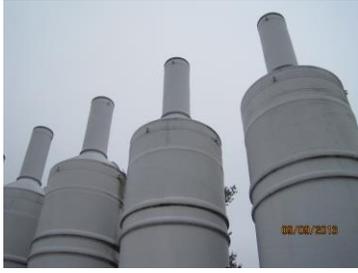
<p>12A</p>	<p>It was reported that the well is often frequently operated during the summer high demand season. The well is outfitted with packed tower air strippers used to remove VOCs (primarily hydrocarbons) from the Time Oil site. There is an expanded metal vent on top of each of the stripper air exhaust stacks to prevent bird entry. However, they do not prevent surface water from entering the stripping towers. The openings must be covered with some sort of a vent covering to prevent surface water entry into the towers. A recommended air filter was located and installed for the air intakes. This will reduce the potential of drawing airborne contaminants into the stripping towers.</p>

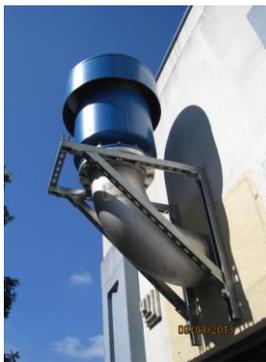
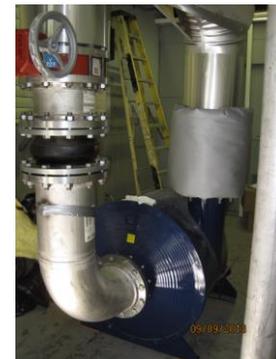
The South Tacoma Pump Station is the largest single pump station in the Tacoma Water system. The pump station consists of four turbine motor driven booster pumps with a total capacity of 15 to 17 MGD. The pump station is fed by Wells 1B, 8B and the wells located south of the pump station. The pump station supplies the West End Transmission Line to the west end of the distribution system and eventually provides water to the north end. It is typically run during periods of high demand or low flow in PL1.

Fine bubble diffusers had been installed in the pump station wet well as part of a corrosion control project (DOH Project # 11-0717). At the time of the survey, startup was dependent upon

successful acceptance testing of the system. The blower air intake was well protected by a vent cap and was outfitted with an air filter.

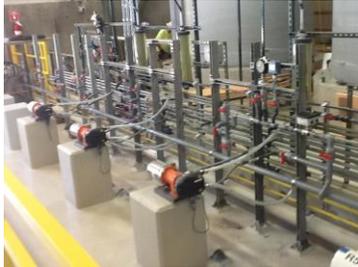
Chemical Treatment Facility

Construction activities were observed in the Chemical Treatment Facility. Chemical storage tanks were being installed and, in some cases, replaced. Chemical injection systems were being modified for the filtration plant. It was reported that these activities had caused a low chlorine episode a month ago when flow looped back through a peristaltic pump that had recently been moved. The flow meter indicated proper flow to the injection point but it was not able to detect that some of the flow was looping back into the system through this pump. Minimum CT requirements were reported to have been met by taking ozone CT into account. Repairs have been made including installation of check valves to prevent this loop flow from reoccurring. It was reported that diaphragm pumps will be installed as part of the filtration plant project.

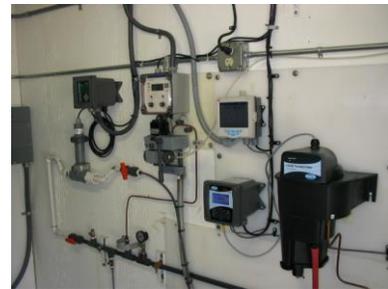
The Covington Turnout is the point of CT compliance for R5 and PL5 located next to Kentlake High School. It is the first of two interties with the Covington Water District. Water quality samples are taken from the 16-inch line that is fed by PL5 (60" at turnout). It was reported during the previous survey that the sample water can be somewhat stagnant if Covington is not drawing water. However, it was reported that Covington has since purchased a share of the North Fork blending facilities as part of the filtration plant project and can now take water at all times. A data logger on-site collects and stores data for chlorine, turbidity, pH, and temperature. These parameters can also be read from Tacoma Water's waterworks control center building in the city. The turbidimeter (1720 E) is cleaned every week. It was unclear whether it has been calibrated recently. ***It is recommended that the turbidimeter be recalibrated once per quarter.*** There is an autostart generator on-site for power outages. At the time of the survey the following values were noted: Cl₂ – 1.4 mg/L, Turbidity – 0.89 NTU, pH – 7.95, Temperature – 17 °C. The facilities were in excellent condition.

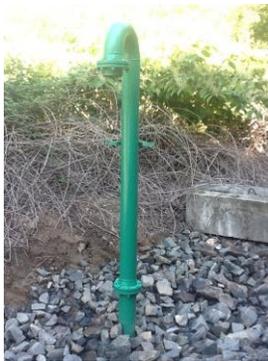
Cumberland PS & Reservoir

The Cumberland Pump Station and Reservoir are located in King County. The turnout at this location feeds the Cumberland portion of Tacoma Water's service area, which serves approximately 94 direct service customers and wholesale service to Cumberland Co-Op. The pump station pumps from PL1 to the reservoir and consists of two pumps each capable of 100 gpm to the reservoir. The pump station is in a vault and appeared to

be in good condition. Operation of the pumps is controlled by the water level in reservoir. The reservoir is cleaned every three years. Since the previous survey the buried overflow has been disconnected and an above grade overflow structure with outlet screening has been installed. This is a significant improvement from the previous survey. The roof is accessed annually by Tacoma Water staff and a screened vent was visible from the ground. The reservoir is not visible to the community and it was reported that the hatch was welded shut to prevent vandalism and unauthorized access. The facilities appeared to be in adequate condition.

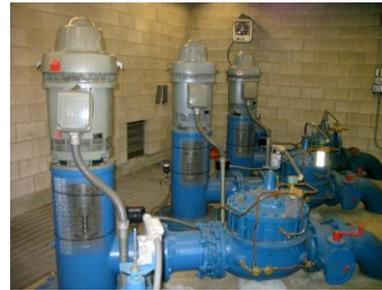
The 214th Avenue Pump Station is located southeast of Bonney Lake and is the CT compliance point for Reactor 1 and Pipeline 1 (PL1). The NaOH injection facilities have not been used since the 2009 survey and the chemical levels in the tank have not changed since the 2009 survey. Because pH is being raised in PL1 at the Headworks, the NaOH facility at the pump station is only used during high flows with low temperatures in order to meet CT requirements. This has not been necessary with the startup of PL5 as flows are typically split between the two transmission pipelines. Since the completion of PL5, PL1 flows have been lower than historical flows in the pipeline. The facilities were in very good condition. It is unclear how the treatment facilities would respond to being started up after such a long down time.

At the time the pump station was visited the following water quality parameters were noted: Cl₂ – 1.36 mg/L, pH – 7.76, Temperature – 67 deg F, Turbidity – 0.96 NTU. There is no monitoring redundancy at the pump station. The next point of chlorine and pH monitoring occurs downstream at the inlet to the new McMillin Reservoirs. Tacoma Water is considering moving the CT point of compliance further upstream on PL1 after completion of the filtration plant.

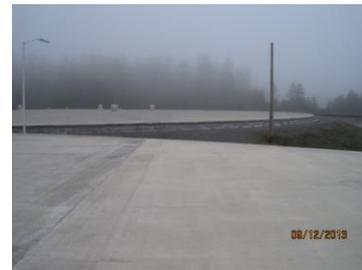
McMillin Reservoir

The two 33-million gallon covered pre-stressed concrete reservoirs have been constructed since the previous survey and were in operation. There are no longer any uncovered reservoirs in Tacoma Water’s distribution system. The remaining existing uncovered North Basins have been physically disconnected from the distribution system. This is an additional improvement since the previous survey. The North Basins will be available to collect water from PL1 that is not intended for the distribution system. Water from the North Basins can then be discharged to the Puyallup River drainage.

Historically, water from the uncovered reservoirs was rechlorinated using a chlorine gas facility that used 1-ton chlorine gas cylinders. The covered reservoirs have greatly limited the amount of chlorine off-gassing and decay that was normally associated with the uncovered reservoirs. It was reported that winter chlorine reductions from inlet to the outlet have typically been around 0.1 mg/L. The reductions have typically been around 0.3 mg/L in the summer. At the time of the survey the chlorine drop was approximately

0.36 mg/L (inlet Cl₂ – 1.34 mg/L and outlet Cl₂ – 0.98 mg/L). The pH was unchanged at 7.80 at both the inlet and outlet. It is anticipated that the drop in chlorine will be even smaller after the filtration plant is completed. The chlorine gas cylinders have been removed from the site and rechlorination is no longer practiced at the McMillin site. It was reported that each reservoir will be drained and cleaned this fall as part of the warranty conditions for the reservoir.

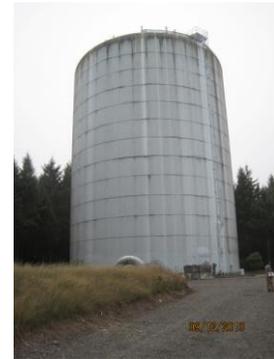
The Sunrise Reservoir is a 104-foot high steel tank that serves a pressure zone south of McMillin Reservoir which is supplied by booster pump stations located south of the reservoirs. To improve the free chlorine residuals in the tank the amount of operational storage has been increased. Tacoma Water increased the operational storage level prior to the previous sanitary from 3 feet to 9 feet to improve circulation. Changes were also made in the operation of the booster pump stations that feed the pressure zone. The tank appeared to be in good condition. The roof is accessed annually and in response to intrusion alarms. The roof was last accessed in April. It was reported that the screened vents and hatches were in good shape.

A chlorine analyzer monitors chlorine residual on the fill/discharge line. During periods when the tank is filling with fresh water from the McMillin Reservoir site the analyzer reads levels consistent with water coming from the Headworks into the McMillin Reservoir. This is typically around 1.3 mg/L. When the tank is discharging the analyzer reads the chlorine levels from the bottom of the tank where water is discharging. At the time of the survey the chlorine residual was 0.53 mg/L which indicates the tank was discharging. The free chlorine residual is monitored at the waterworks control center.

The overflow outlet was improved with a smaller mesh screen at the discharge structure. This is an improvement since the previous survey.

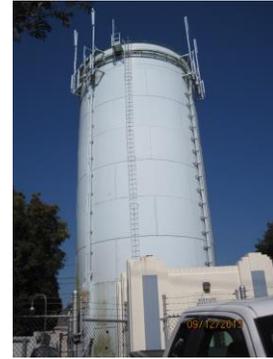
The Bismark Standpipe is a steel tank on E. 64th Street that feeds the 478 pressure zone. The reservoir is fed from the 581 zone via PL4 through an altitude valve. A PRV provides inlet control. There were no reported stagnation issues. The reservoir roof is accessed annually for vent inspection or to respond to intrusion alarms. It was reported that birds sometime set off the motion sensor. The overflow outlet discharges to a stormwater catch basin and was screened. This is an improvement from the previous survey.

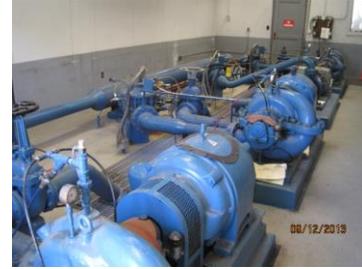
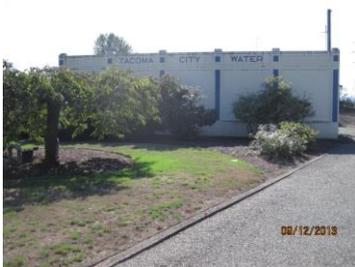
The Marine View Drive Pump Station is a four pump booster station with a capacity of 8.5 MGD. It can be used to pump water from the Tideflats area of Tacoma up to NE Tacoma and the Indian Hills Reservoirs. However, the completion of PL5 and the 356th Ave. Pump Station in general has eliminated the need for the pump station to operate to supply NE Tacoma. It was reported that it is used briefly once per week in the summer and every other week in the winter to prevent stagnation issues in the distribution system near the pump station.

The pump station plays a significant role in Tacoma Water's Groundwater Rule Triggered Monitoring Plan. If the pump station is not in use, only surface water can enter NE Tacoma. If it is in use water from the Hood Street Reservoir, which receives water from the South Tacoma Wellfield, can reach the pump station and NE Tacoma. In this scenario, positive routine coliform samples from NE Tacoma would require raw water sampling from the South Tacoma Wells that were in use at the time of the positive sample collection.

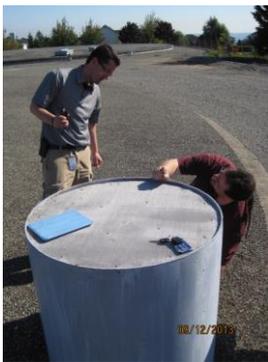
The Indian Hills Reservoir is located in NE Tacoma and is actually a set of four reservoirs located at the site: 3.5-million gallons, 1-million gallons, and two 250,000 gallon tanks. All are concrete reservoirs at or below grade. The two small tanks are buried and are not visible. There are two small booster pump stations located at the site that feed the pressure zone at the top of the hills where the reservoirs are located. The reservoirs are primarily fed from PL5. The overflow outlet of the two largest reservoirs discharges to a manhole at a lower elevation than the reservoirs. The outlet was screened. The reservoir vents were screened but with a fine mesh screen mesh. This is an improvement from the previous survey. The vent for the mid-sized reservoir was enclosed in a metal cylinder (pictured). *It was unclear whether the cylinder could fill with water and flow into the reservoir. If water can collect in the cylinder and overflow into the reservoir it would be a Significant Deficiency.* The hatches for all of the reservoirs were locked. The largest reservoir's hatch had a rubber gasketed seal. *The mid-sized and two smallest reservoir hatches must be outfitted with a rubber gasket seal.*

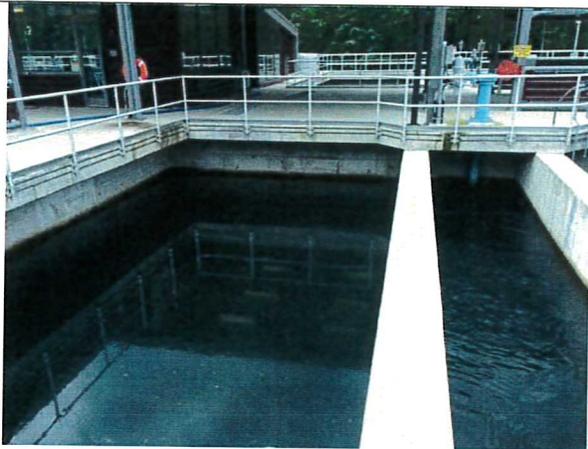
Filter Basin

A fine pin floc was observed in the filters above the media. Flocculation energy is tapered through the floc basins.
